# Home Report

# Single Survey

| Property address | Top Floor Left<br>98 Holburn Street<br>Aberdeen<br>AB10 6BY |
| Date of inspection | 23/07/2026 |

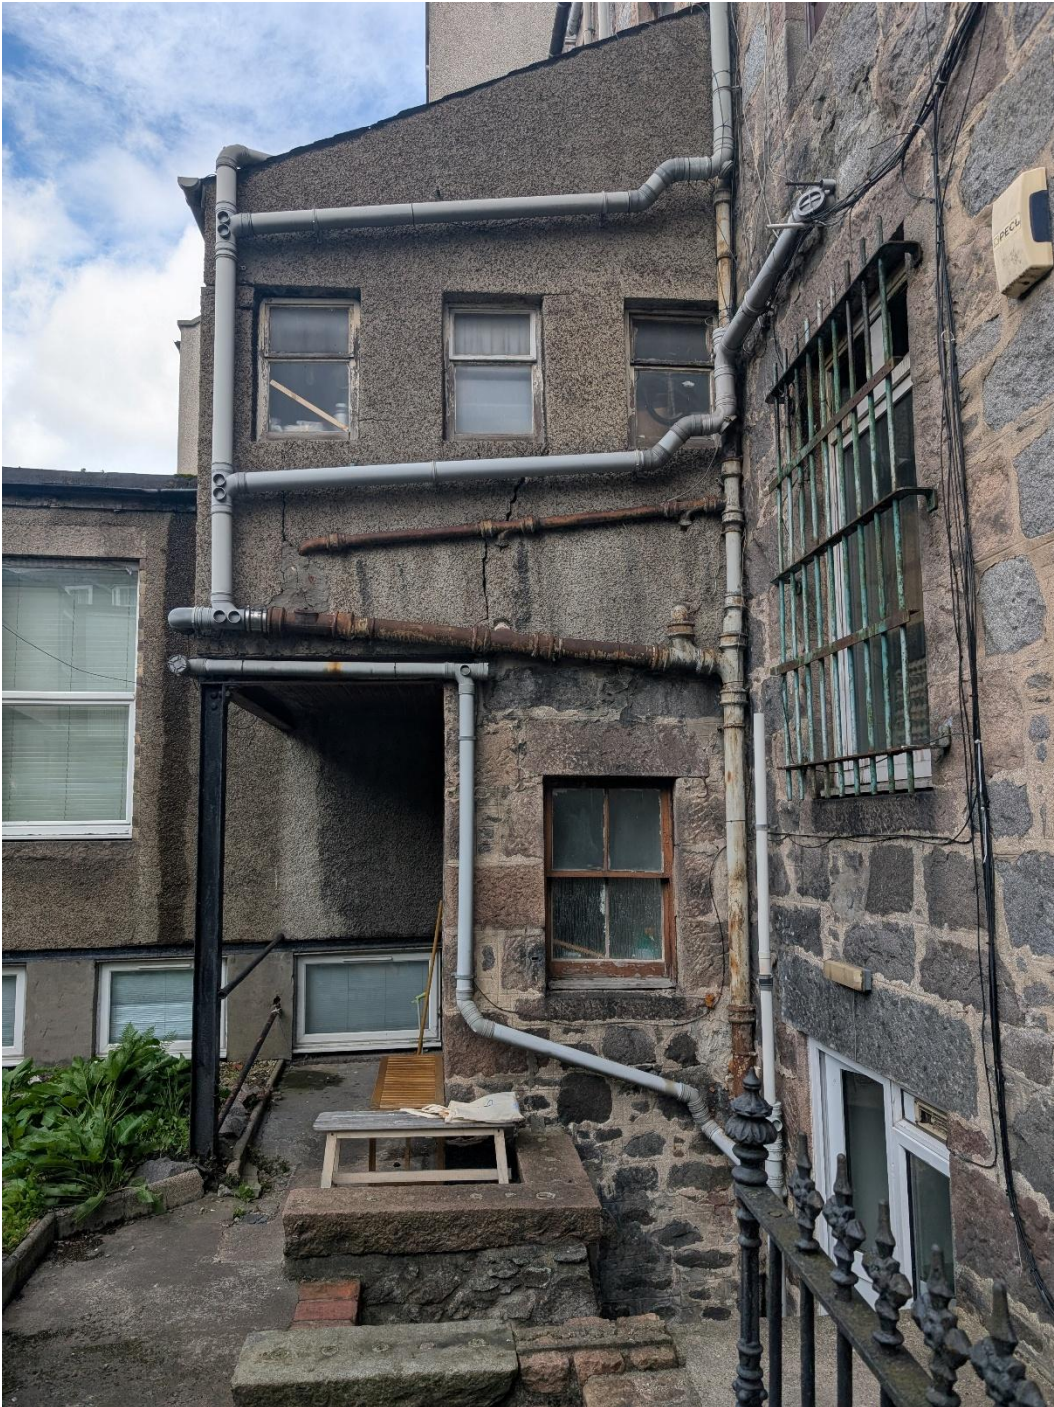
There was open and pronounced cracking to rear annexe projection. We have had sight of a report produced by Messrs Ramsay & Chalmers Consulting Structural & Civil Engineers dated 11th August 2025. Their report has concluded the cause of movement is likely due to corrosion to the supporting steelwork, and they have outlined the necessary repairs to "reduce the rate of corrosion and maintain the structure in a safe condition for a reasonable lifespan". These repairs have not been costed and it would be prudent to establish the cost of repairs prior to purchase, although these would likely be shared. Copies of this report should be obtained.

Fig. 1 – Rear washhouse/toilet block showing extensive cracking to harled brickwork and multiple rainwater/soil pipes.

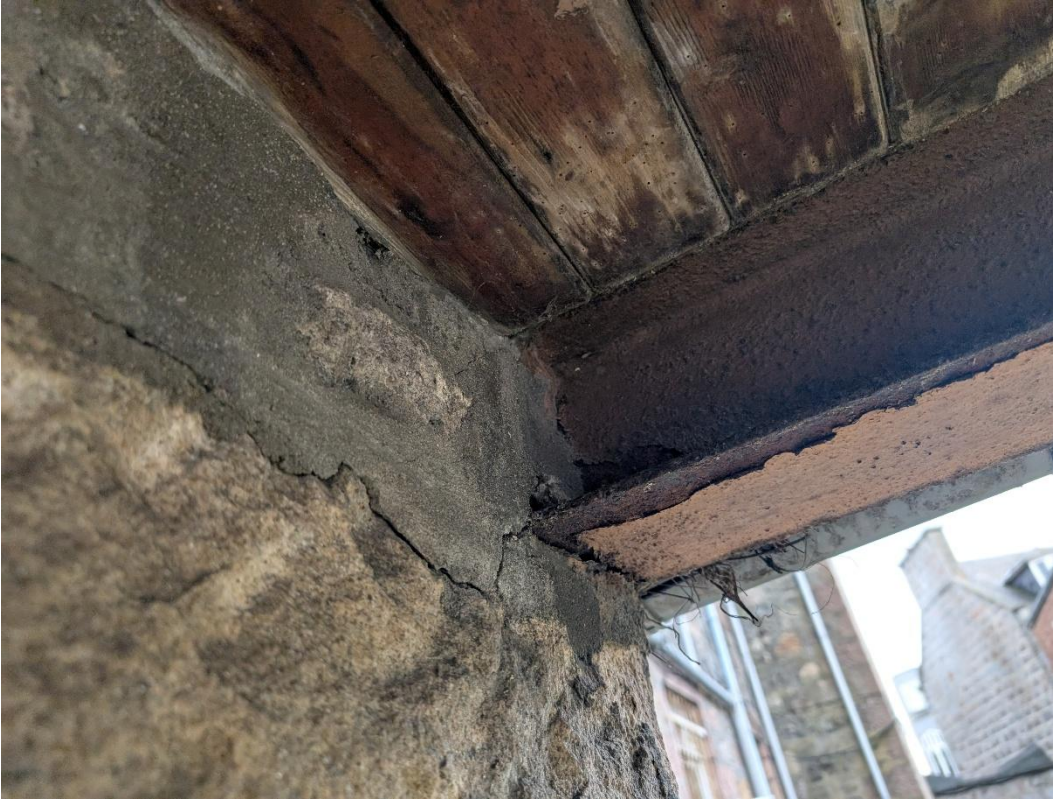
Fig. 2 – Steel beam bearing into masonry with associated cracking.

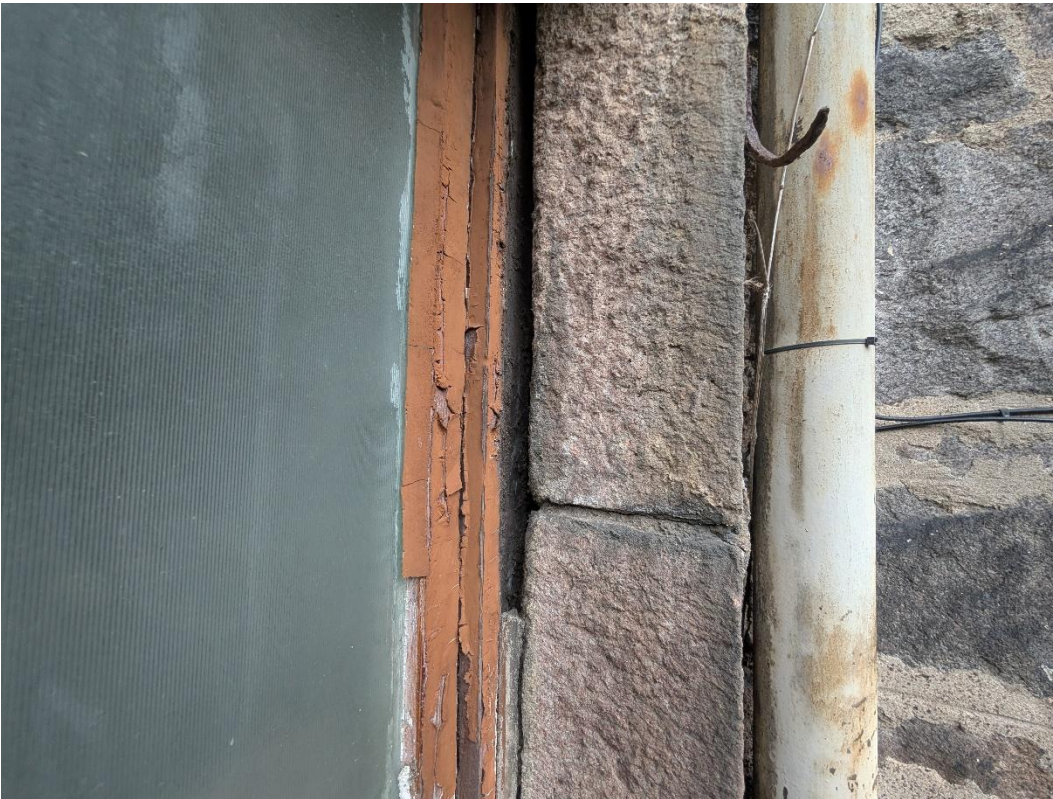
Fig. 3 – Window frame showing decay and gap to masonry reveal.

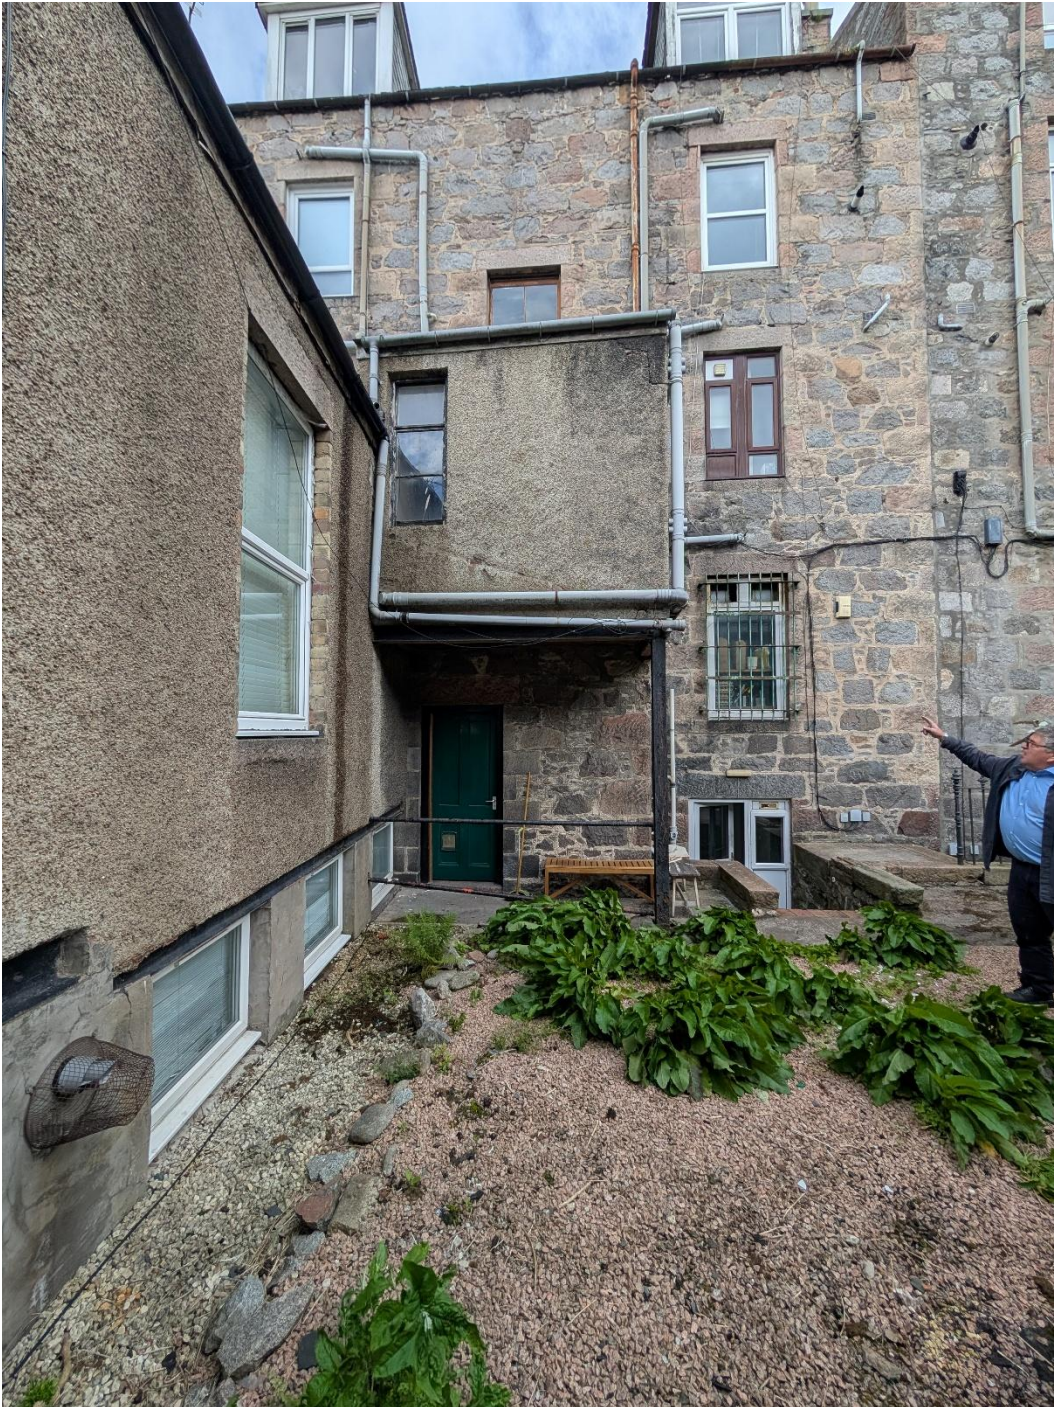
Fig. 4 – Rear elevation showing washhouse/toilet block in relation to main granite building.
