# Home Report

# Single Survey

| Property address | Top Floor Left<br>98 Holburn Street<br>Aberdeen<br>AB10 6BY |
| Date of inspection | 23/07/2026 |

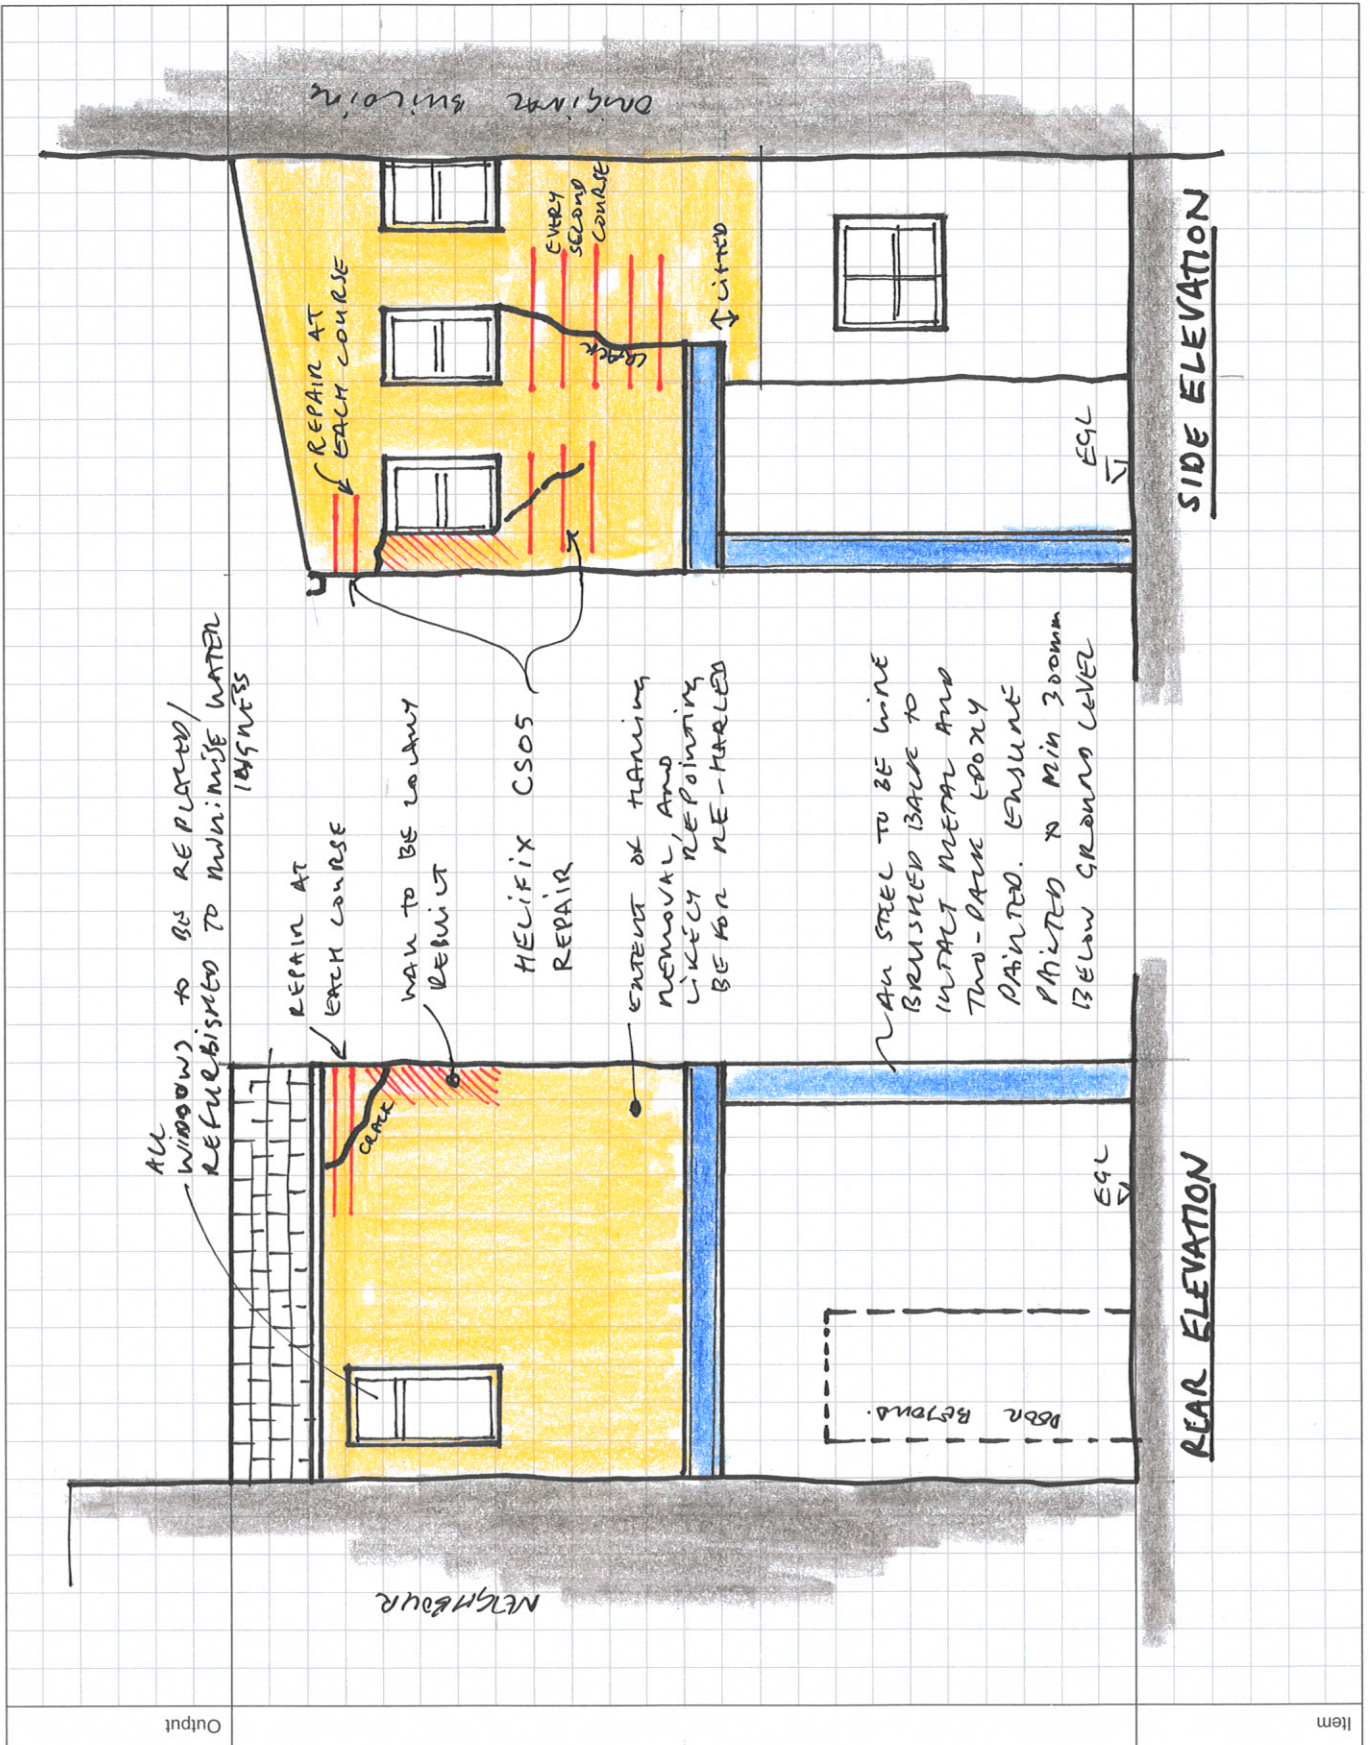
Project 94 D The Burnn Street  
Section  
Job No C8855  
By ETS  
Date 11.08.2025  
Page SK2508 11#1  
Checked

- 3.1 Cracking is most pronounced at the interface between the steel support beams and the adjoining stonework, radiating upward and opening with height. This cracking pattern is consistent with rotational movement about the central steel column. While settlement of the column is possible, the more probable cause is corrosion of the steel beams at their bearing points, leading to localised expansion and “jacking” of the brickwork (Fig. 1, Fig. 4).
