Home Report

**13a Oldmeldrum
Road, Newmachar
Aberdeen, AB21 0PN**

ASPC ref. 362192

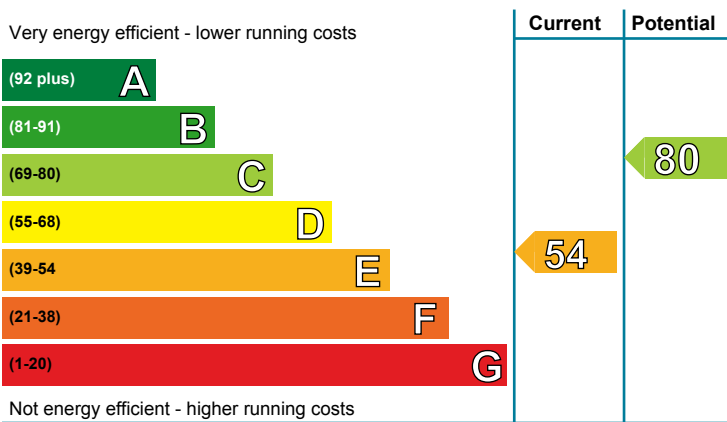
Energy Efficiency Rating

This graph shows the current efficiency of your home, taking into account both energy efficiency and fuel costs. The higher this rating, the lower your fuel bills are likely to be.

Your current rating is **band E (54)**. The average rating for EPCs in Scotland is **band D (61)**.

The potential rating shows the effect of undertaking all of the improvement measures listed within your recommendations report.
