# Home Report

**7 Railway Terrace, Port Elphinstone**  
Inverurie, AB51 3RL

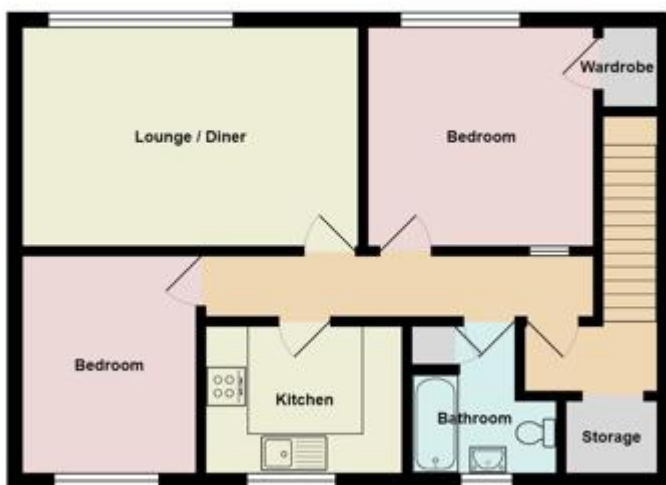
### Floorplan

7 Railway Terrace

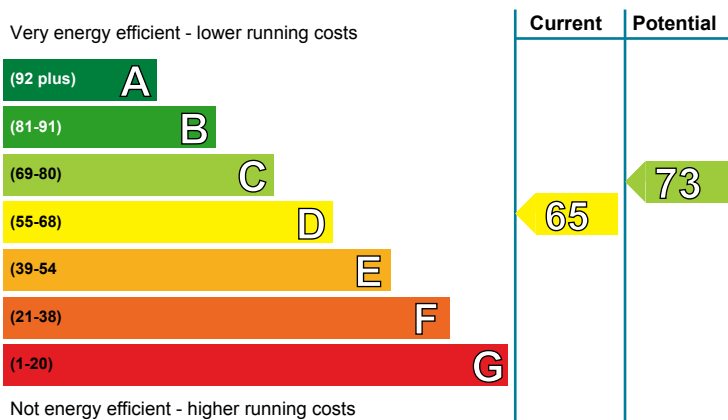
## Energy Efficiency Rating

This graph shows the current efficiency of your home, taking into account both energy efficiency and fuel costs. The higher this rating, the lower your fuel bills are likely to be.

Your current rating is **band D (65)**. The average rating for EPCs in Scotland is **band D (61)**.

The potential rating shows the effect of undertaking all of the improvement measures listed within your recommendations report.

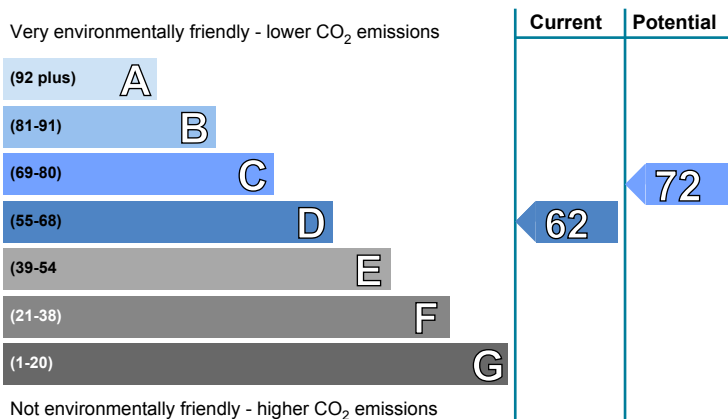
## Environmental Impact (CO<sub>2</sub>) Rating

This graph shows the effect of your home on the environment in terms of carbon dioxide (CO<sub>2</sub>) emissions. The higher the rating, the less impact it has on the environment.
