# Single Survey

<b>Property address</b>	Flat F, 57 Menzies Road, Aberdeen, AB11 9AS
-------------------------	--

<b>Prepared by</b>	ALLIED SURVEYORS SCOTLAND PLC
--------------------	-------------------------------

<b>Date of inspection</b>	18th April 2023
---------------------------	-----------------

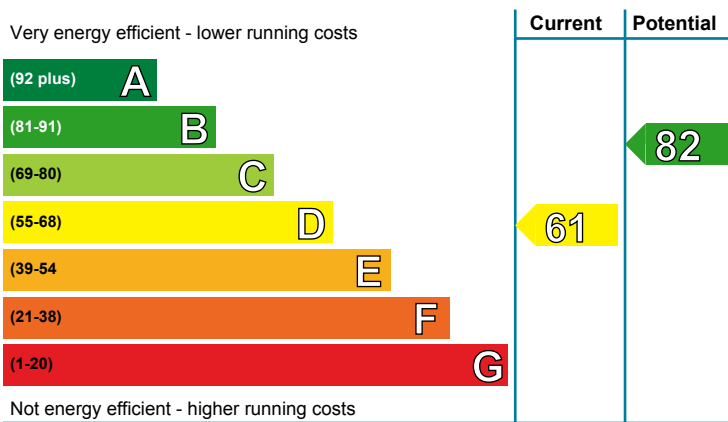
## Energy Efficiency Rating

This graph shows the current efficiency of your home, taking into account both energy efficiency and fuel costs. The higher this rating, the lower your fuel bills are likely to be.

Your current rating is **band D (61)**. The average rating for EPCs in Scotland is **band D (61)**.

The potential rating shows the effect of undertaking all of the improvement measures listed within your recommendations report.

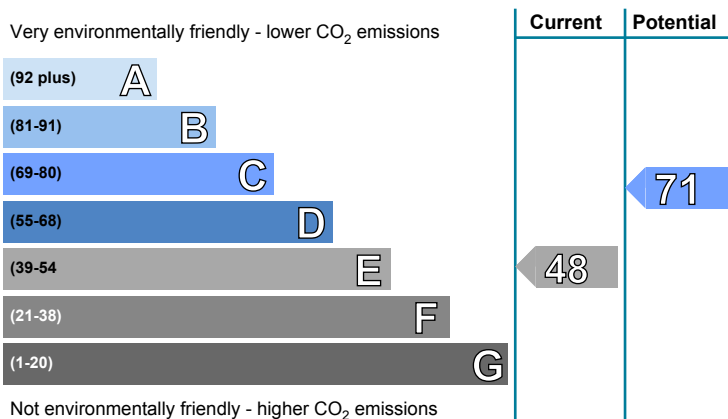
## Environmental Impact (CO<sub>2</sub>) Rating

This graph shows the effect of your home on the environment in terms of carbon dioxide (CO<sub>2</sub>) emissions. The higher the rating, the less impact it has on the environment.
