Home Report

**Flat 10, Fraser House 9 Market
Street,
Aberdeen, AB11 5PD**

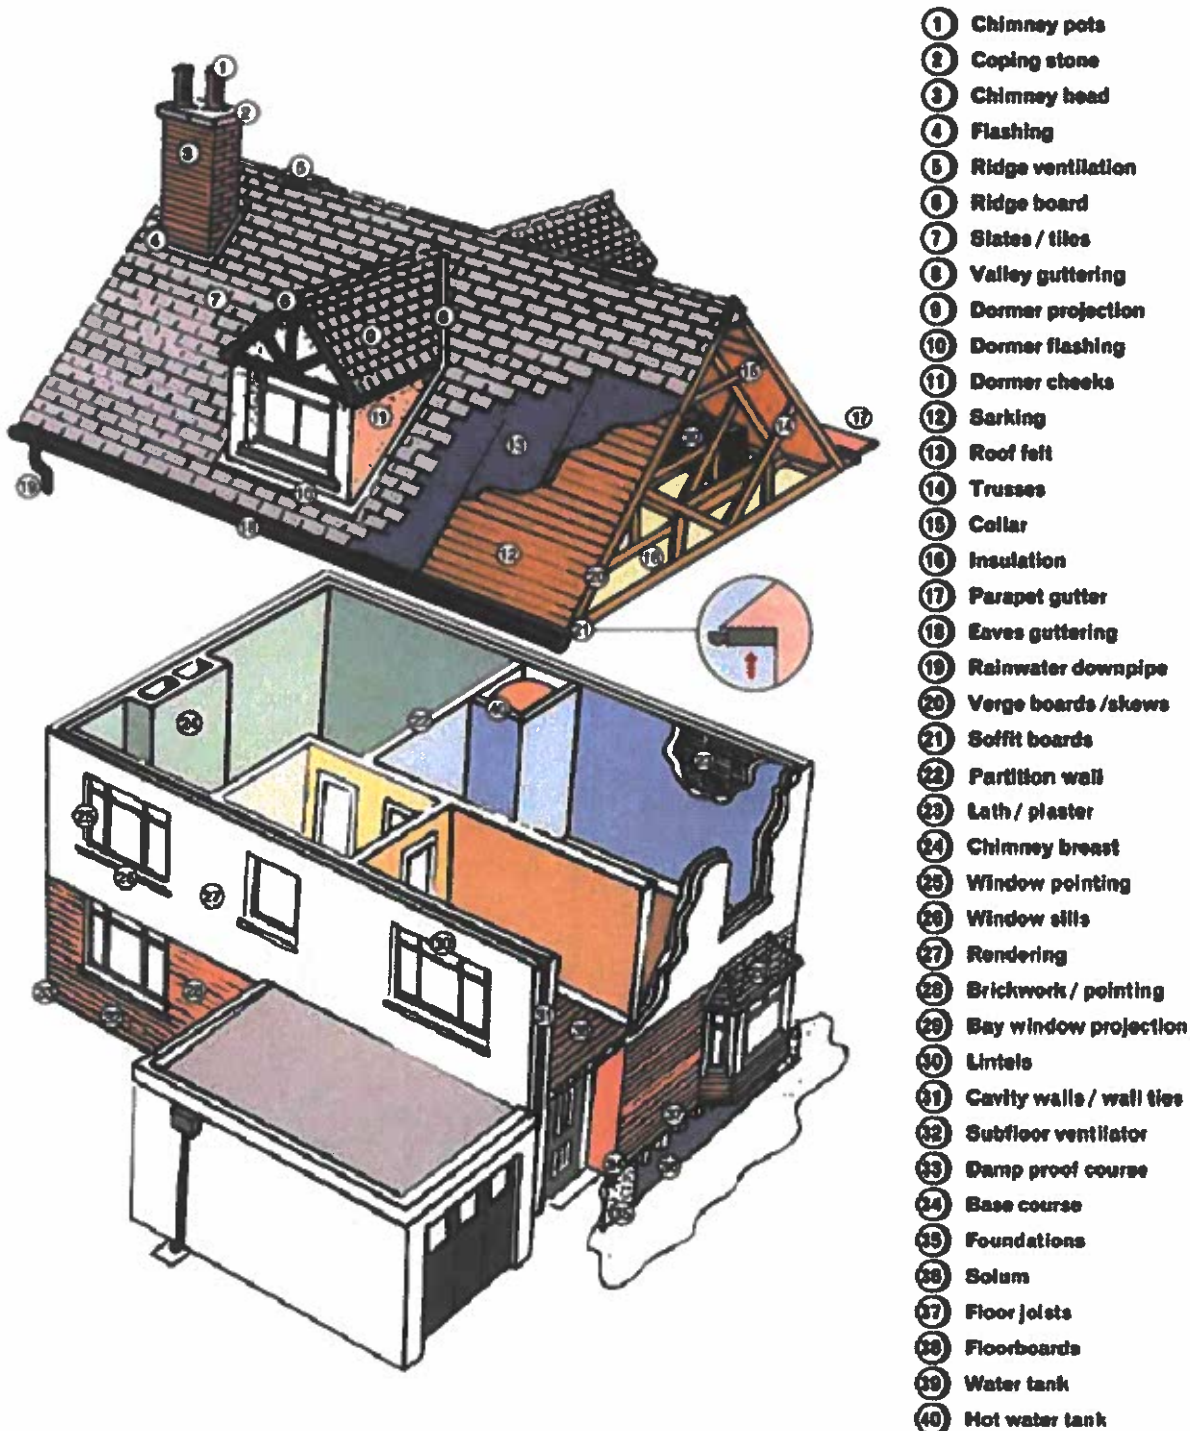
Sectional Diagram showing elements of a typical house

Reference may be made in this report to some or all of the above component parts of the property. This diagram may assist you in locating and understanding these items.

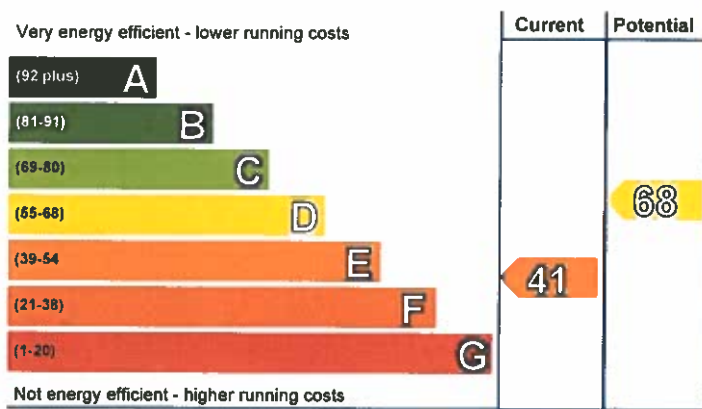
Energy Efficiency Rating

This graph shows the current efficiency of your home, taking into account both energy efficiency and fuel costs. The higher this rating, the lower your fuel bills are likely to be.

Your current rating is **band E (41)**. The average rating for EPCs in Scotland is **band D (61)**.

The potential rating shows the effect of undertaking all of the improvement measures listed within your recommendations report.

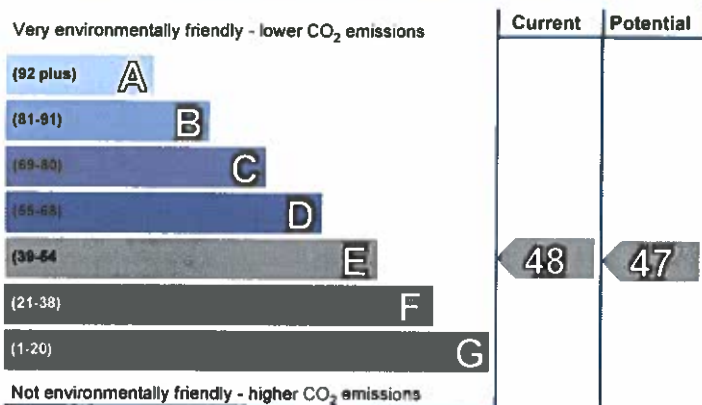
Environmental Impact (CO₂) Rating

This graph shows the effect of your home on the environment in terms of carbon dioxide (CO₂) emissions. The higher the rating, the less impact it has on the environment.
