# HOME REPORT

CORNMILL CROFT AUCHLEVEN

INSCH  
AB52 6QD

# Single Survey

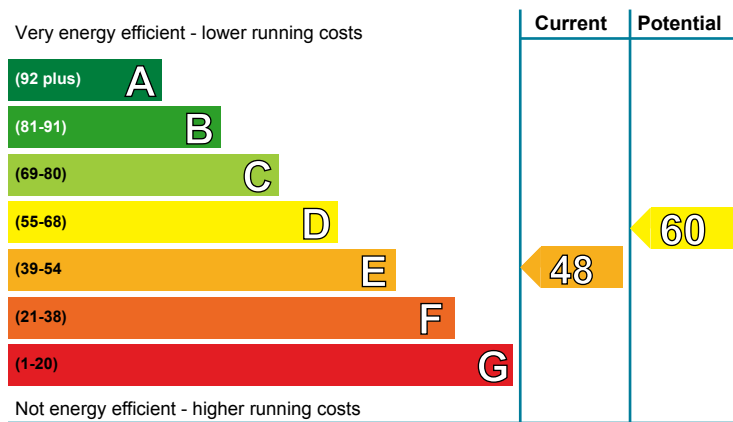
## Energy Efficiency Rating

This graph shows the current efficiency of your home, taking into account both energy efficiency and fuel costs. The higher this rating, the lower your fuel bills are likely to be.

Your current rating is **band E (48)**. The average rating for EPCs in Scotland is **band D (61)**.

The potential rating shows the effect of undertaking all of the improvement measures listed within your recommendations report.

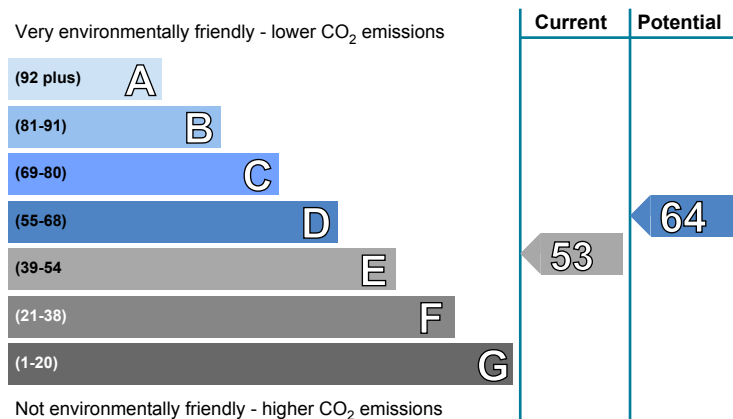
## Environmental Impact (CO<sub>2</sub>) Rating

This graph shows the effect of your home on the environment in terms of carbon dioxide (CO<sub>2</sub>) emissions. The higher the rating, the less impact it has on the environment.

Your current rating is **band E (53)**. The average rating for EPCs in Scotland is **band D (59)**.

The potential rating shows the effect of undertaking all of the improvement measures listed within your recommendations report.
