Home Report

Scottish Single Survey

Property address	23 Dee Village Millburn Street Aberdeen AB11 6LG
Customer	Nicola Ross
Customer address	23 Dee Village Millburn Street Aberdeen AB11 6LG
Prepared by	Shepherd Chartered Surveyors
Date of inspection	19/12/2024

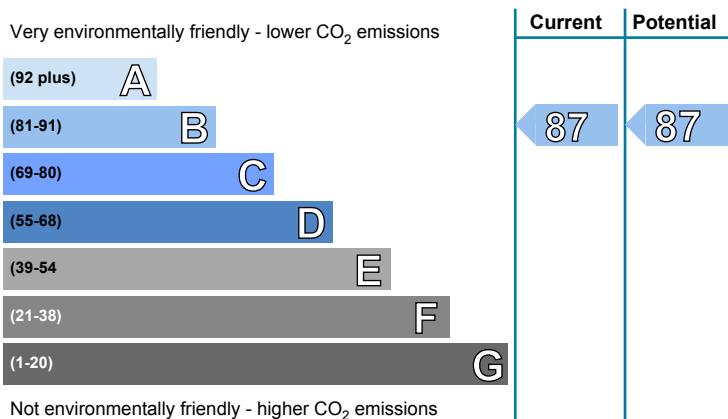
Environmental Impact (CO₂) Rating

This graph shows the effect of your home on the environment in terms of carbon dioxide (CO₂) emissions. The higher the rating, the less impact it has on the environment.
