Home Report

2 Summer Brae, Newmachar **Aberdeen, AB21 0PQ**

Price Over
£140,000

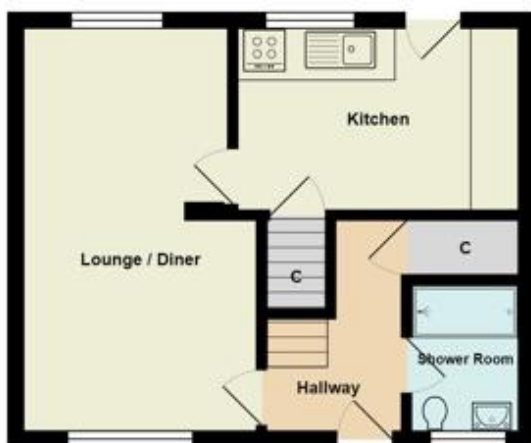
Floorplan

2 Summer Brae
