Home Report

**96a High Street,
Inverurie, AB51 3QL**

Accommodation comprises

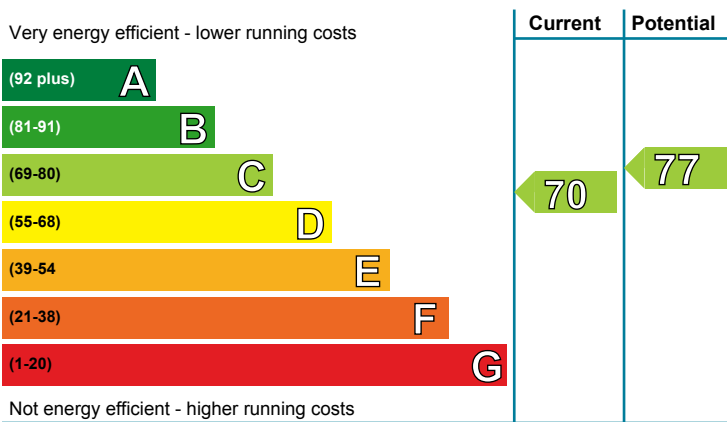
Energy Efficiency Rating

This graph shows the current efficiency of your home, taking into account both energy efficiency and fuel costs. The higher this rating, the lower your fuel bills are likely to be.

Your current rating is **band C (70)**. The average rating for EPCs in Scotland is **band D (61)**.

The potential rating shows the effect of undertaking all of the improvement measures listed within your recommendations report.

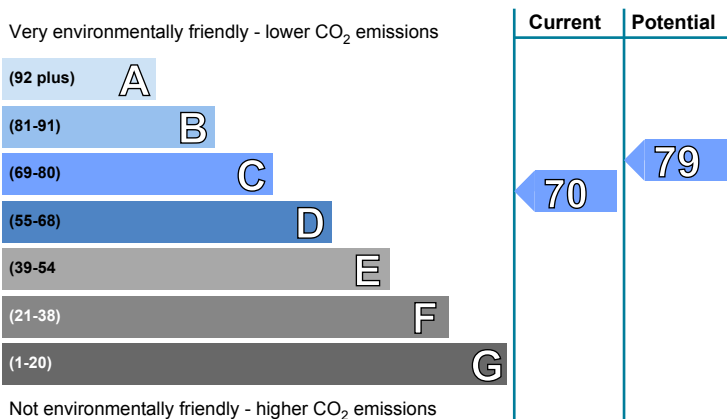
Environmental Impact (CO₂) Rating

This graph shows the effect of your home on the environment in terms of carbon dioxide (CO₂) emissions. The higher the rating, the less impact it has on the environment.
