Home Report

1 Homely Cottage Market Place, Inverurie, AB51 3PU

1 Homely Cottage, Market Place,

Inverurie, AB51 3PU

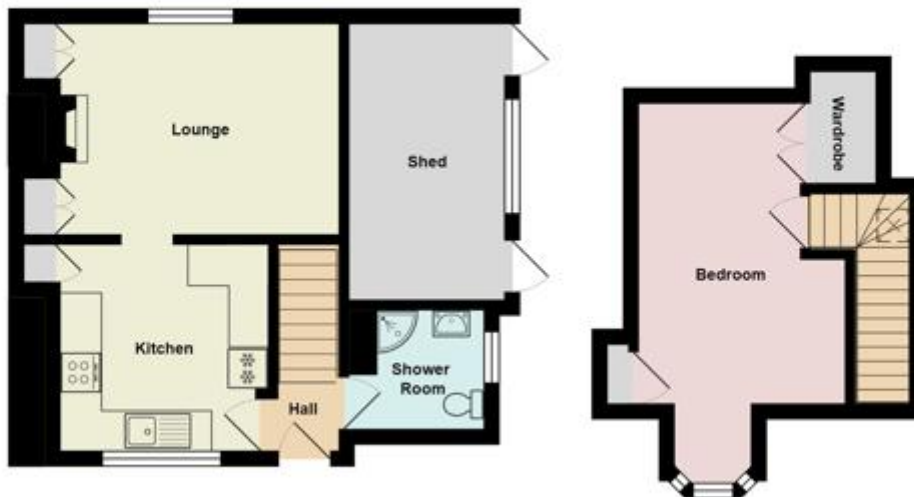
Floorplan

1 Homely Cottage
