HOME REPORT

Flat 3
53 Deveron Street
Huntly
AB54 8BZ

Energy Performance Certificate (EPC)

Single Survey

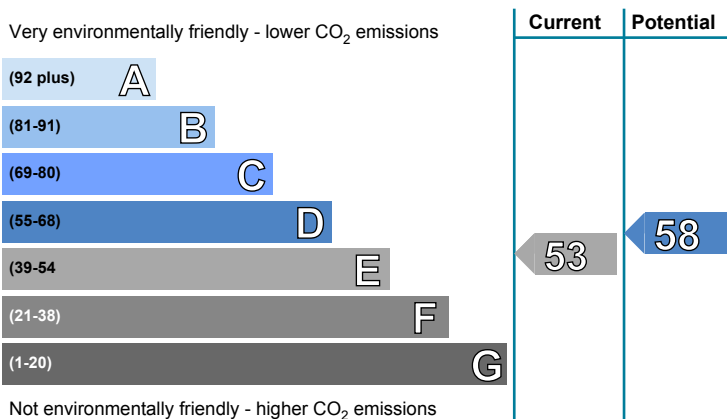
Environmental Impact (CO₂) Rating

This graph shows the effect of your home on the environment in terms of carbon dioxide (CO₂) emissions. The higher the rating, the less impact it has on the environment.

Your current rating is **band E (53)**. The average rating for EPCs in Scotland is **band D (59)**.

The potential rating shows the effect of undertaking all of the improvement measures listed within your recommendations report.
