9 BETTERAL ROAD
KINGSEAT
ABERDEEN
AB21 0AT

Home Report

Energy Performance Certificate (EPC)

Scottish Single Survey

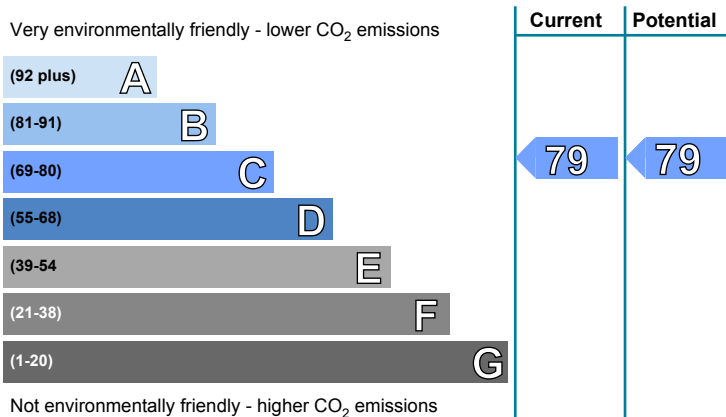
Environmental Impact (CO₂) Rating

This graph shows the effect of your home on the environment in terms of carbon dioxide (CO₂) emissions. The higher the rating, the less impact it has on the environment.

Your current rating is **band C (79)**. The average rating for EPCs in Scotland is **band D (59)**.

The potential rating shows the effect of undertaking all of the improvement measures listed within your recommendations report.
