# Home Report

**76 Selbie Drive,  
Inverurie, AB51 3YD**

# Single Survey

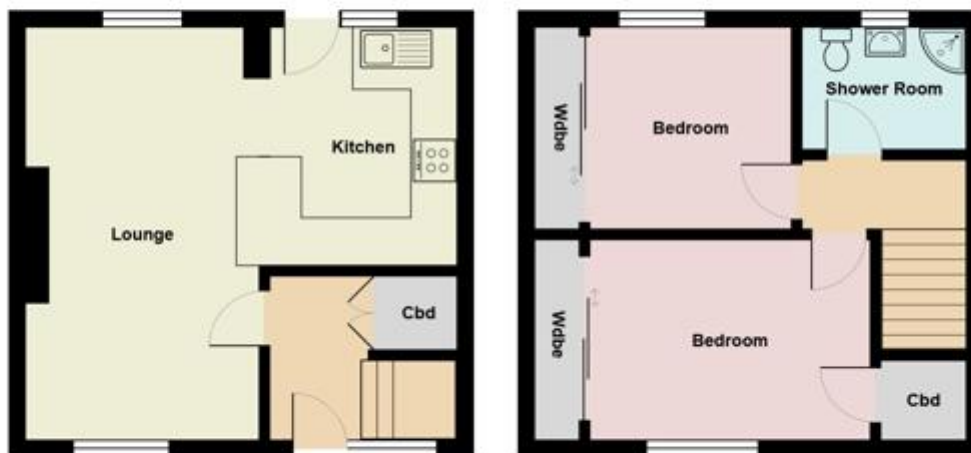
### Floorplan

76 Selbie Drive
