# Home Report

**24 Garioch Road,  
Inverurie, AB51 4RQ**

<b>Customer</b>	Norman & Lorna Burns
-----------------	----------------------

<b>Prepared by</b>	Shepherd Chartered Surveyors
--------------------	------------------------------

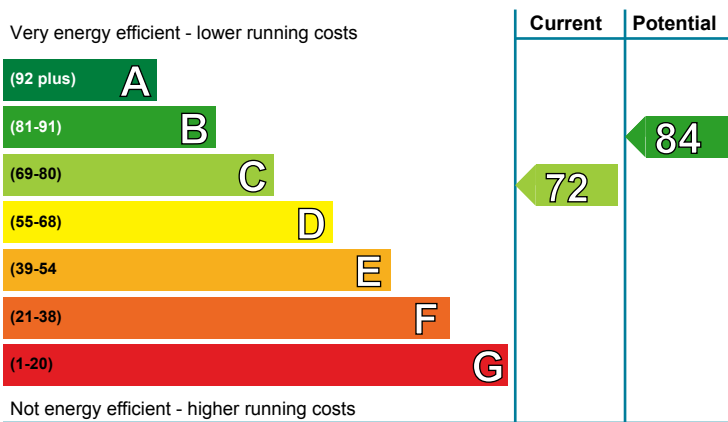
## Energy Efficiency Rating

This graph shows the current efficiency of your home, taking into account both energy efficiency and fuel costs. The higher this rating, the lower your fuel bills are likely to be.

Your current rating is **band C (72)**. The average rating for EPCs in Scotland is **band D (61)**.

The potential rating shows the effect of undertaking all of the improvement measures listed within your recommendations report.

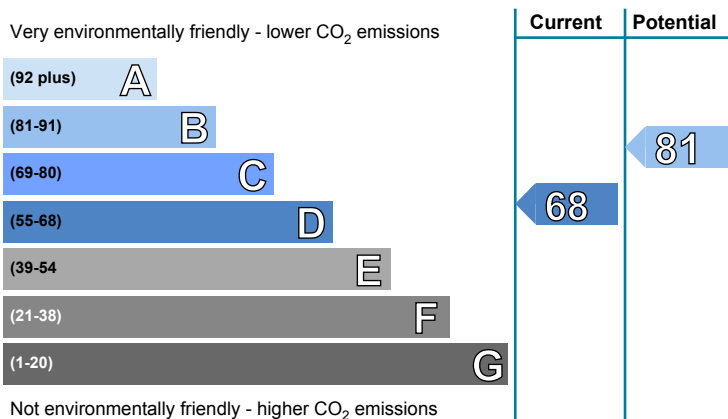
## Environmental Impact (CO<sub>2</sub>) Rating

This graph shows the effect of your home on the environment in terms of carbon dioxide (CO<sub>2</sub>) emissions. The higher the rating, the less impact it has on the environment.
