# Home Report

# Scottish Single Survey

<b>Property address</b>	Old Customs & Excise House Glentauchers Mulben Keith AB55 6YL
-------------------------	---

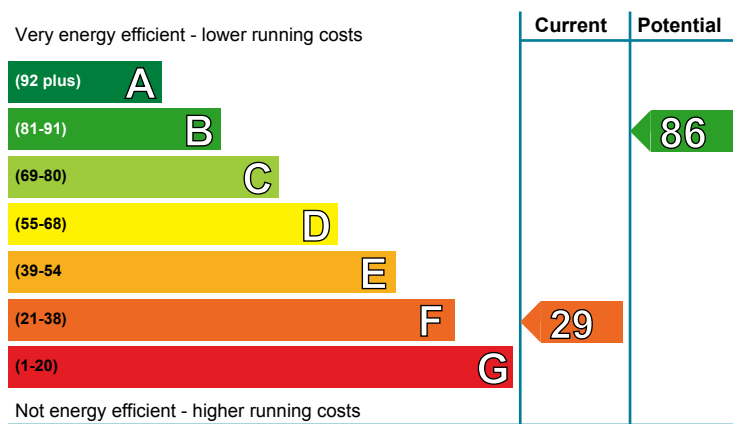
## Energy Efficiency Rating

This graph shows the current efficiency of your home, taking into account both energy efficiency and fuel costs. The higher this rating, the lower your fuel bills are likely to be.

Your current rating is **band F (29)**. The average rating for EPCs in Scotland is **band D (61)**.

The potential rating shows the effect of undertaking all of the improvement measures listed within your recommendations report.

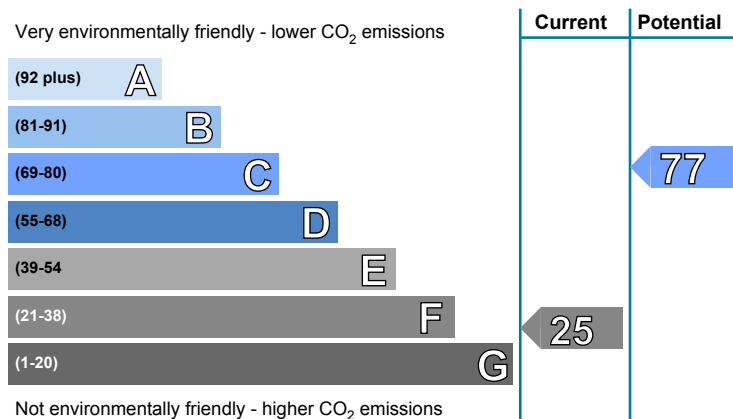
## Environmental Impact (CO<sub>2</sub>) Rating

This graph shows the effect of your home on the environment in terms of carbon dioxide (CO<sub>2</sub>) emissions. The higher the rating, the less impact it has on the environment.
