# Home Report

# Scottish Single Survey

<b>Property address</b>	87 Mile-End Avenue Aberdeen AB15 5PS
<b>Customer</b>	Thomas McInally
<b>Customer address</b>	87 Mile-End Avenue Aberdeen AB15 5PS
<b>Prepared by</b>	Shepherd Chartered Surveyors
<b>Date of inspection</b>	25/07/2024

## Sectional Diagram showing elements of a typical house

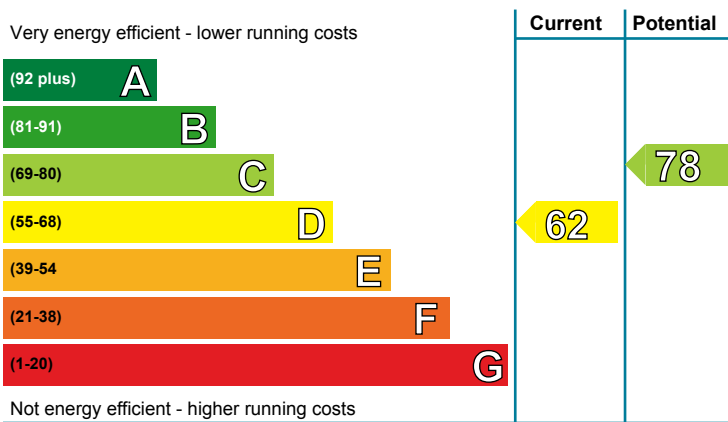
## Energy Efficiency Rating

This graph shows the current efficiency of your home, taking into account both energy efficiency and fuel costs. The higher this rating, the lower your fuel bills are likely to be.

Your current rating is **band D (62)**. The average rating for EPCs in Scotland is **band D (61)**.

The potential rating shows the effect of undertaking all of the improvement measures listed within your recommendations report.

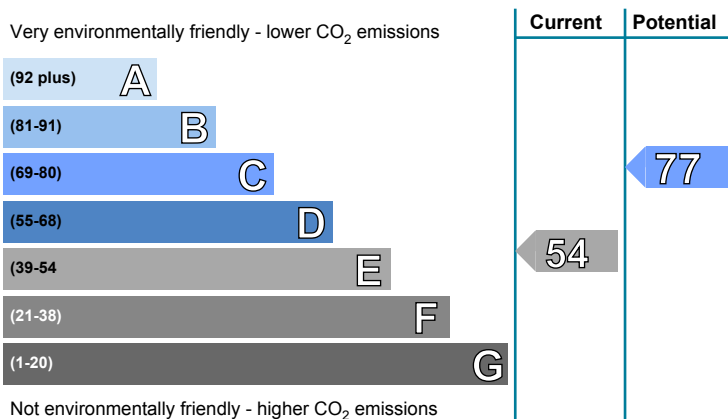
## Environmental Impact (CO<sub>2</sub>) Rating

This graph shows the effect of your home on the environment in terms of carbon dioxide (CO<sub>2</sub>) emissions. The higher the rating, the less impact it has on the environment.
