HOME REPORT

SOUTERS COTTAGE MAIN STREET

LUMSDEN
HUNTLY
AB54 4JP

Energy Performance Certificate (EPC)

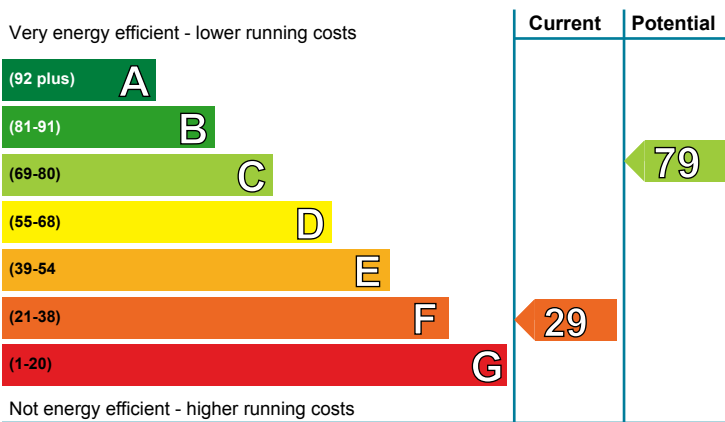
Energy Efficiency Rating

This graph shows the current efficiency of your home, taking into account both energy efficiency and fuel costs. The higher this rating, the lower your fuel bills are likely to be.

Your current rating is **band F (29)**. The average rating for EPCs in Scotland is **band D (61)**.

The potential rating shows the effect of undertaking all of the improvement measures listed within your recommendations report.

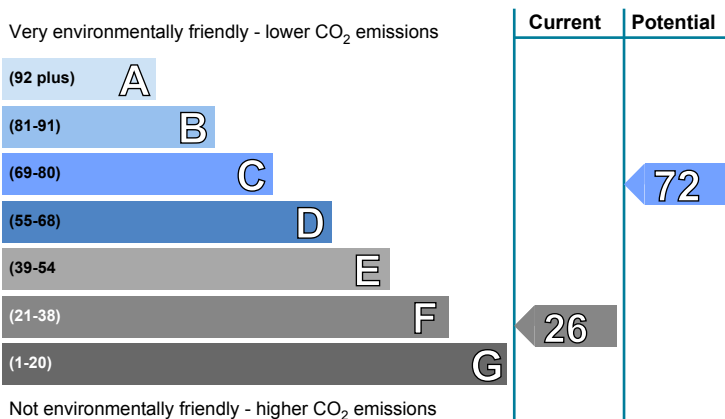
Environmental Impact (CO₂) Rating

This graph shows the effect of your home on the environment in terms of carbon dioxide (CO₂) emissions. The higher the rating, the less impact it has on the environment.

Your current rating is **band F (26)**. The average rating for EPCs in Scotland is **band D (59)**.

The potential rating shows the effect of undertaking all of the improvement measures listed within your recommendations report.

The average Scottish household produces about 6 tonnes of carbon dioxide every year. Based on this assessment, heating and lighting this home currently produces approximately 12 tonnes of carbon dioxide every year. Adopting recommendations in this report can reduce emissions and protect the environment. If you were to install all of these recommendations this could reduce emissions by 7.9 tonnes per year. You could reduce emissions even more by switching to renewable energy sources.
