Home Report

Bents Farmhouse Whitehouse Alford, AB33 8EY

Bents Farmhouse,

Whitehouse, Alford, AB33 8EY

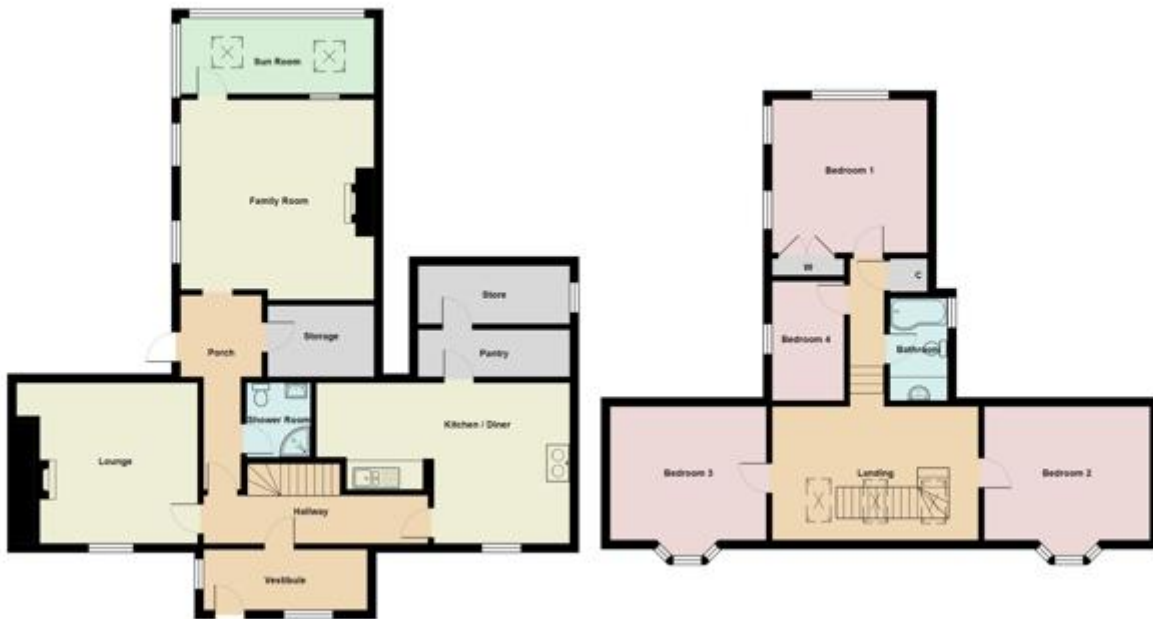
Floorplan

Bents Farmhouse

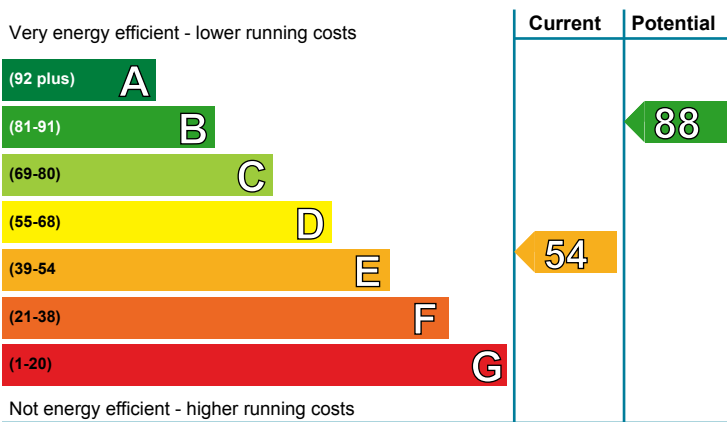
Energy Efficiency Rating

This graph shows the current efficiency of your home, taking into account both energy efficiency and fuel costs. The higher this rating, the lower your fuel bills are likely to be.

Your current rating is **band E (54)**. The average rating for EPCs in Scotland is **band D (61)**.

The potential rating shows the effect of undertaking all of the improvement measures listed within your recommendations report.

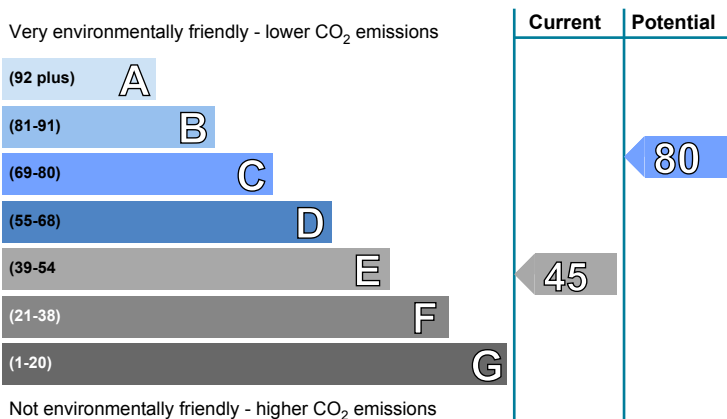
Environmental Impact (CO₂) Rating

This graph shows the effect of your home on the environment in terms of carbon dioxide (CO₂) emissions. The higher the rating, the less impact it has on the environment.
