Home Report

16 Beechgrove Terrace,
Aberdeen, AB15 5ED

Price Over
£215,000

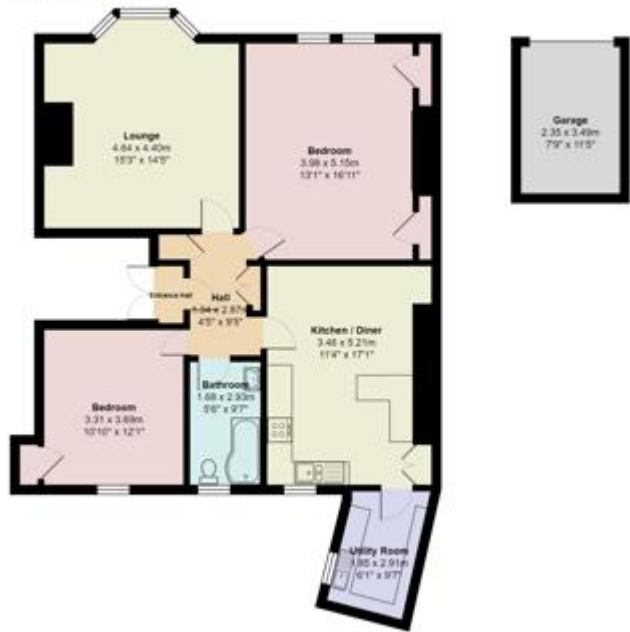
Floorplan

16 Beechgrove Terrace

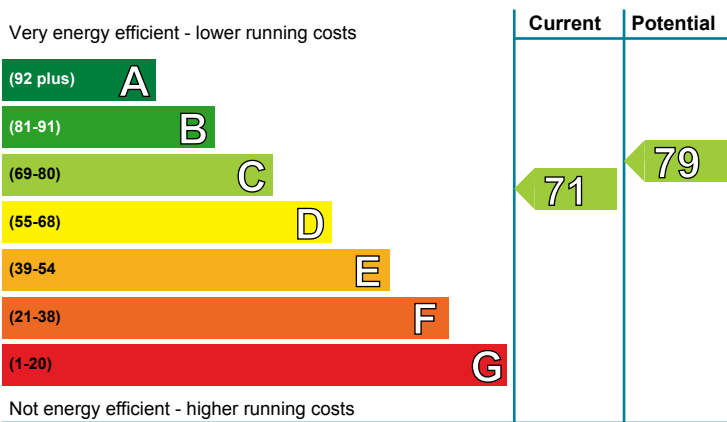
Energy Efficiency Rating

This graph shows the current efficiency of your home, taking into account both energy efficiency and fuel costs. The higher this rating, the lower your fuel bills are likely to be.

Your current rating is **band C (71)**. The average rating for EPCs in Scotland is **band D (61)**.

The potential rating shows the effect of undertaking all of the improvement measures listed within your recommendations report.

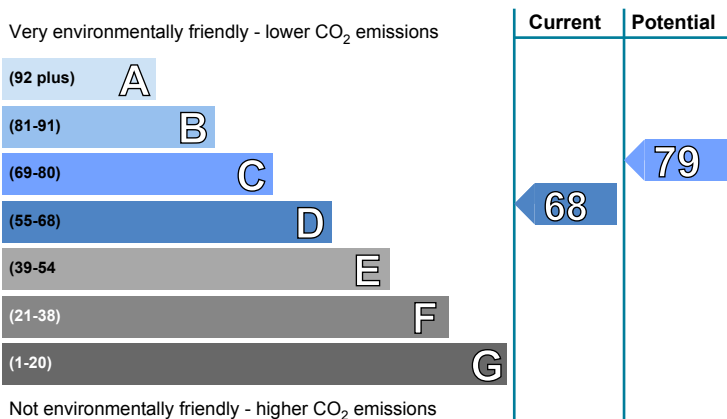
Environmental Impact (CO₂) Rating

This graph shows the effect of your home on the environment in terms of carbon dioxide (CO₂) emissions. The higher the rating, the less impact it has on the environment.
