Home Report

Scottish Single Survey

Property address	10 Whitehills Square Cove Aberdeen AB12 3SW
-------------------------	--

Prepared by	Shepherd Chartered Surveyors
--------------------	------------------------------

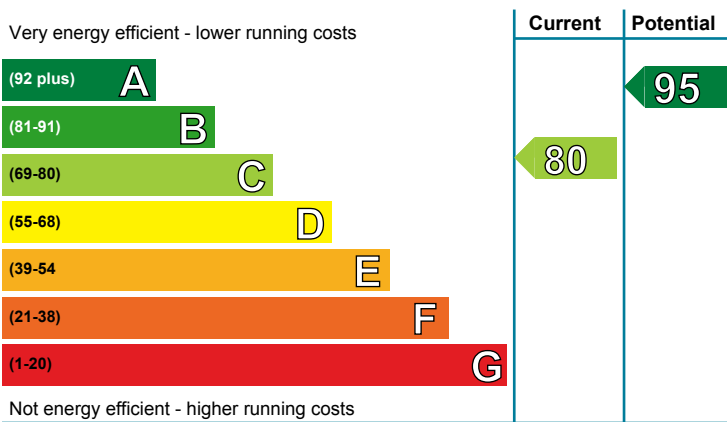
Energy Efficiency Rating

This graph shows the current efficiency of your home, taking into account both energy efficiency and fuel costs. The higher this rating, the lower your fuel bills are likely to be.

Your current rating is **band C (80)**. The average rating for EPCs in Scotland is **band D (61)**.

The potential rating shows the effect of undertaking all of the improvement measures listed within your recommendations report.

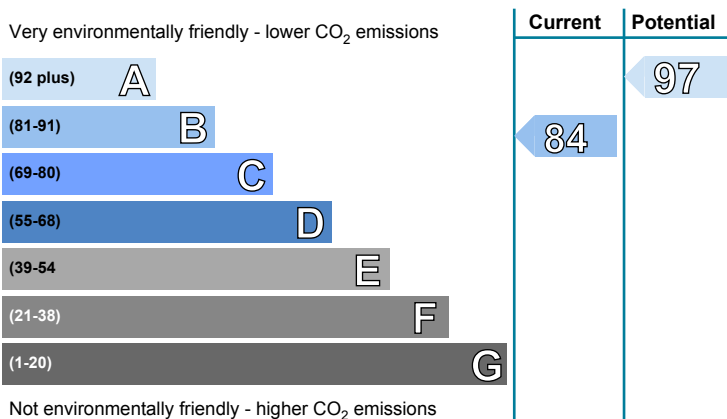
Environmental Impact (CO₂) Rating

This graph shows the effect of your home on the environment in terms of carbon dioxide (CO₂) emissions. The higher the rating, the less impact it has on the environment.
