# Home Report

**Flat 4, Leask House Beverley Road,  
Inverurie, AB51 3PT**

# Single Survey

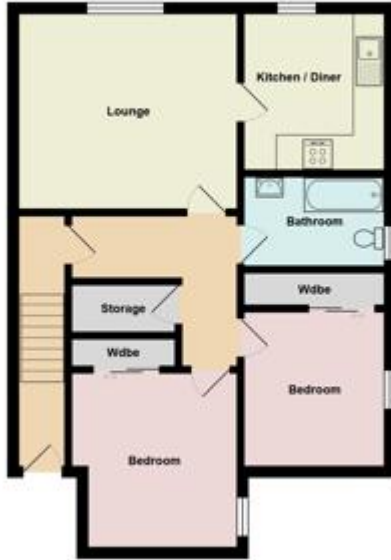
## Floorplan

4 Leask House, Beverley House
