# Home Report

**28 Selbie Drive,  
Inverurie, AB51 3YD**

## Sectional Diagram showing elements of a typical house

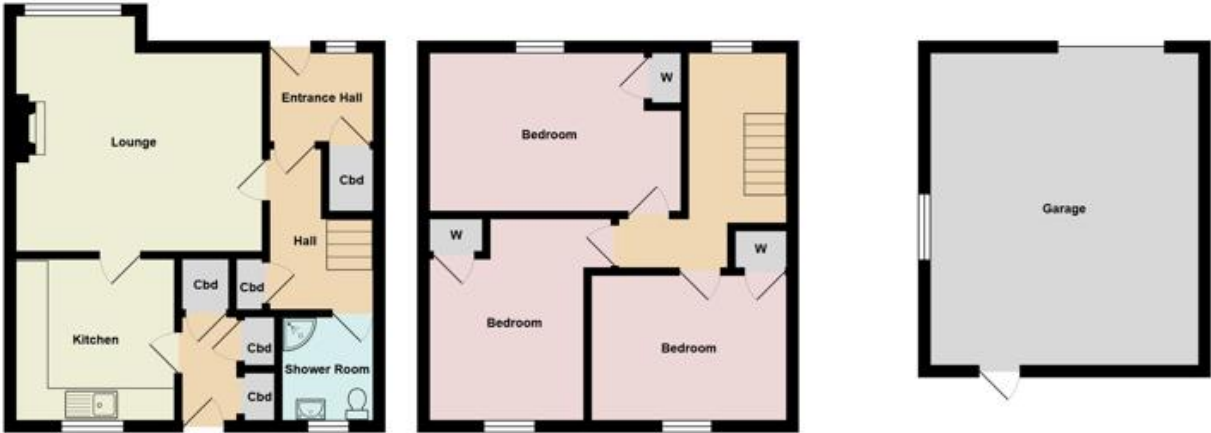
# Floorplan

28 Selbie Drive
