Home Report

12 Cobbans Lane,
Inverurie, AB51 4AU

Single Survey

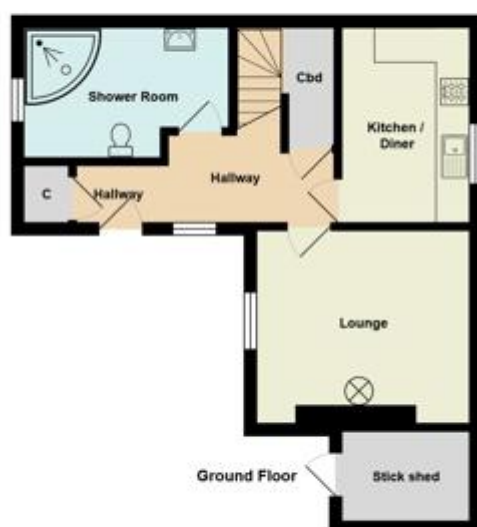
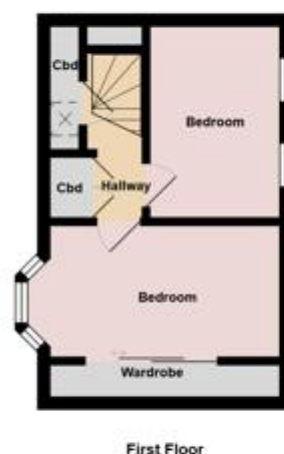
Floorplan

12 Cobban's Lane
