# Home Report

**1 St. Andrews, Monymusk**  
**Inverurie, AB51 7HE**

# Single Survey

## Survey Report on:

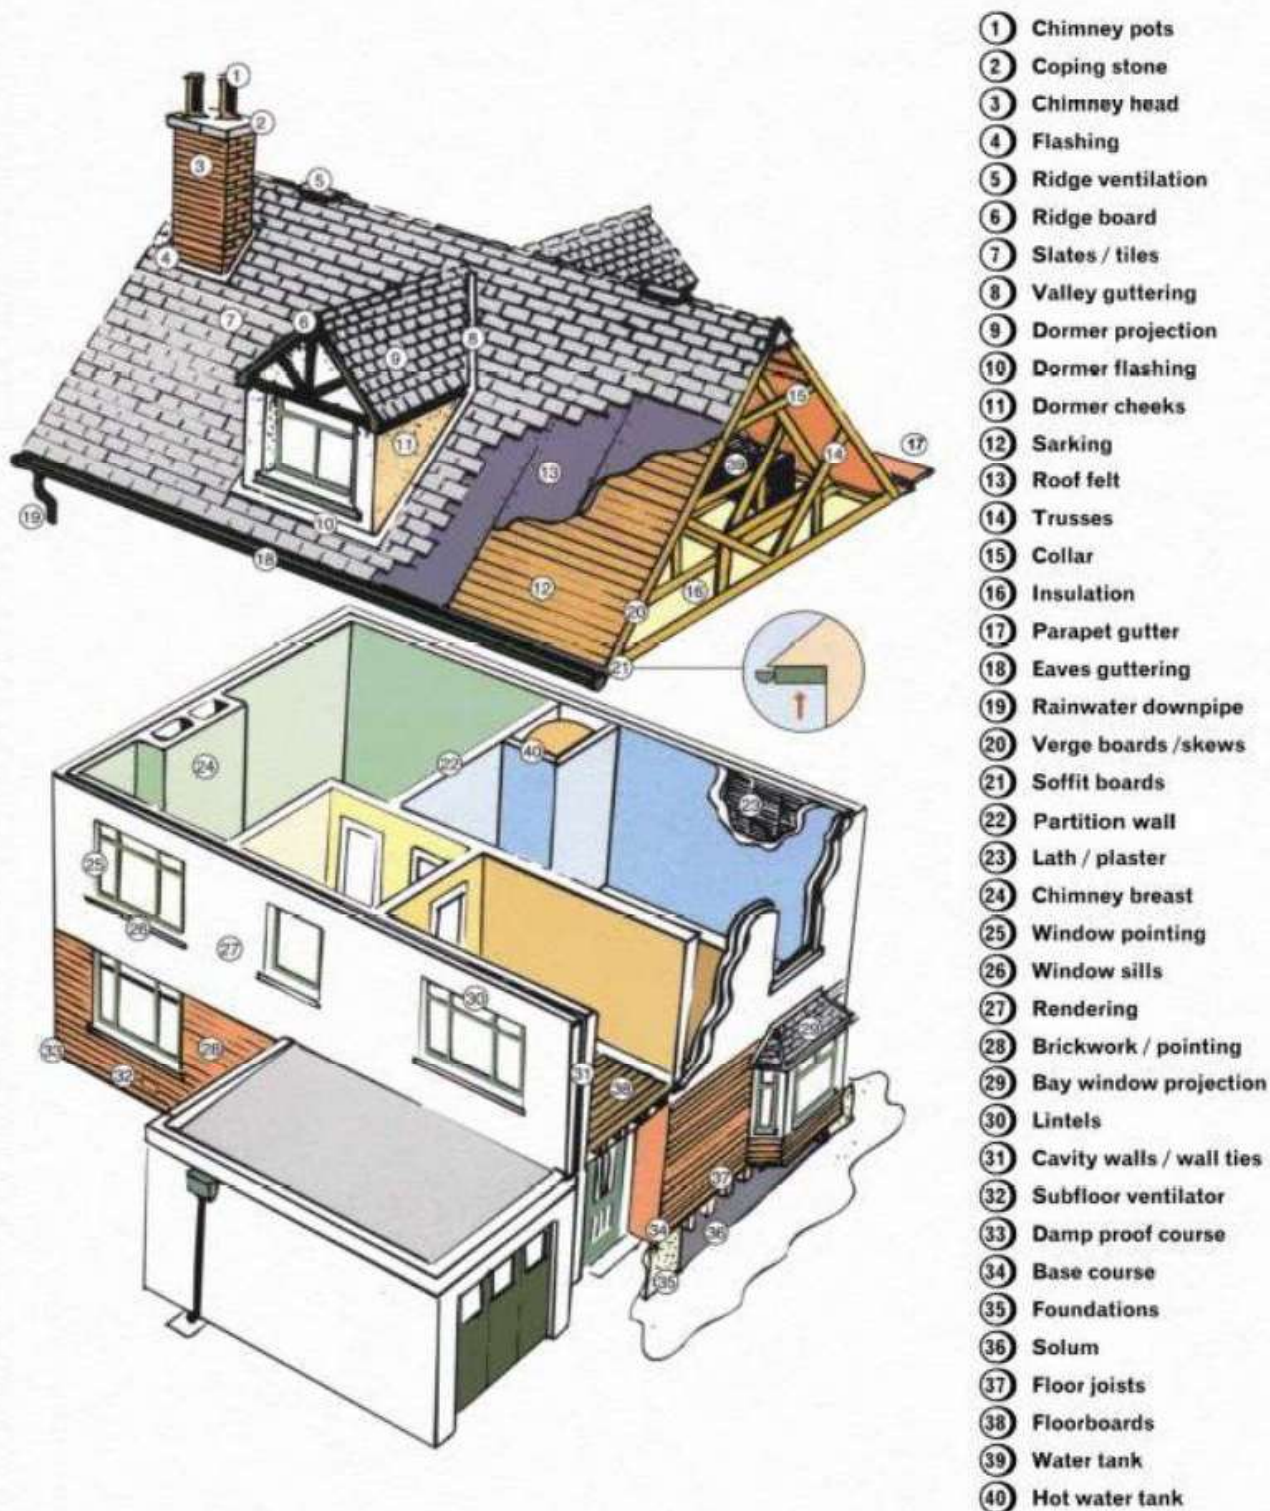
## Sectional Diagram showing elements of a typical house

Reference may be made in this report to some or all of the above component parts of the property. This diagram may assist you in locating and understanding these items.

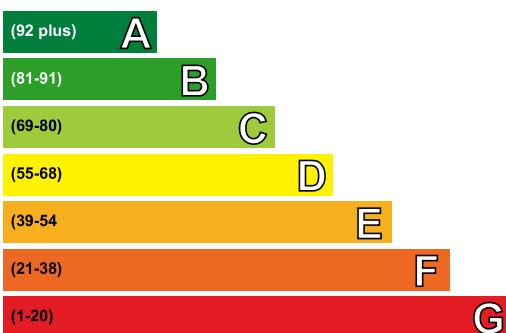
Very energy efficient - lower running costs

Not energy efficient - higher running costs

Current	Potential
56	79

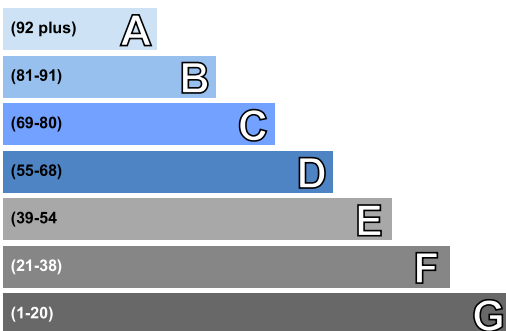
Very environmentally friendly - lower CO<sub>2</sub> emissions

Not environmentally friendly - higher CO<sub>2</sub> emissions

Current	Potential
83	95
