# Home Report

**1 Hill Street, Rosemount**  
Aberdeen, AB25 2XZ

# Single Survey

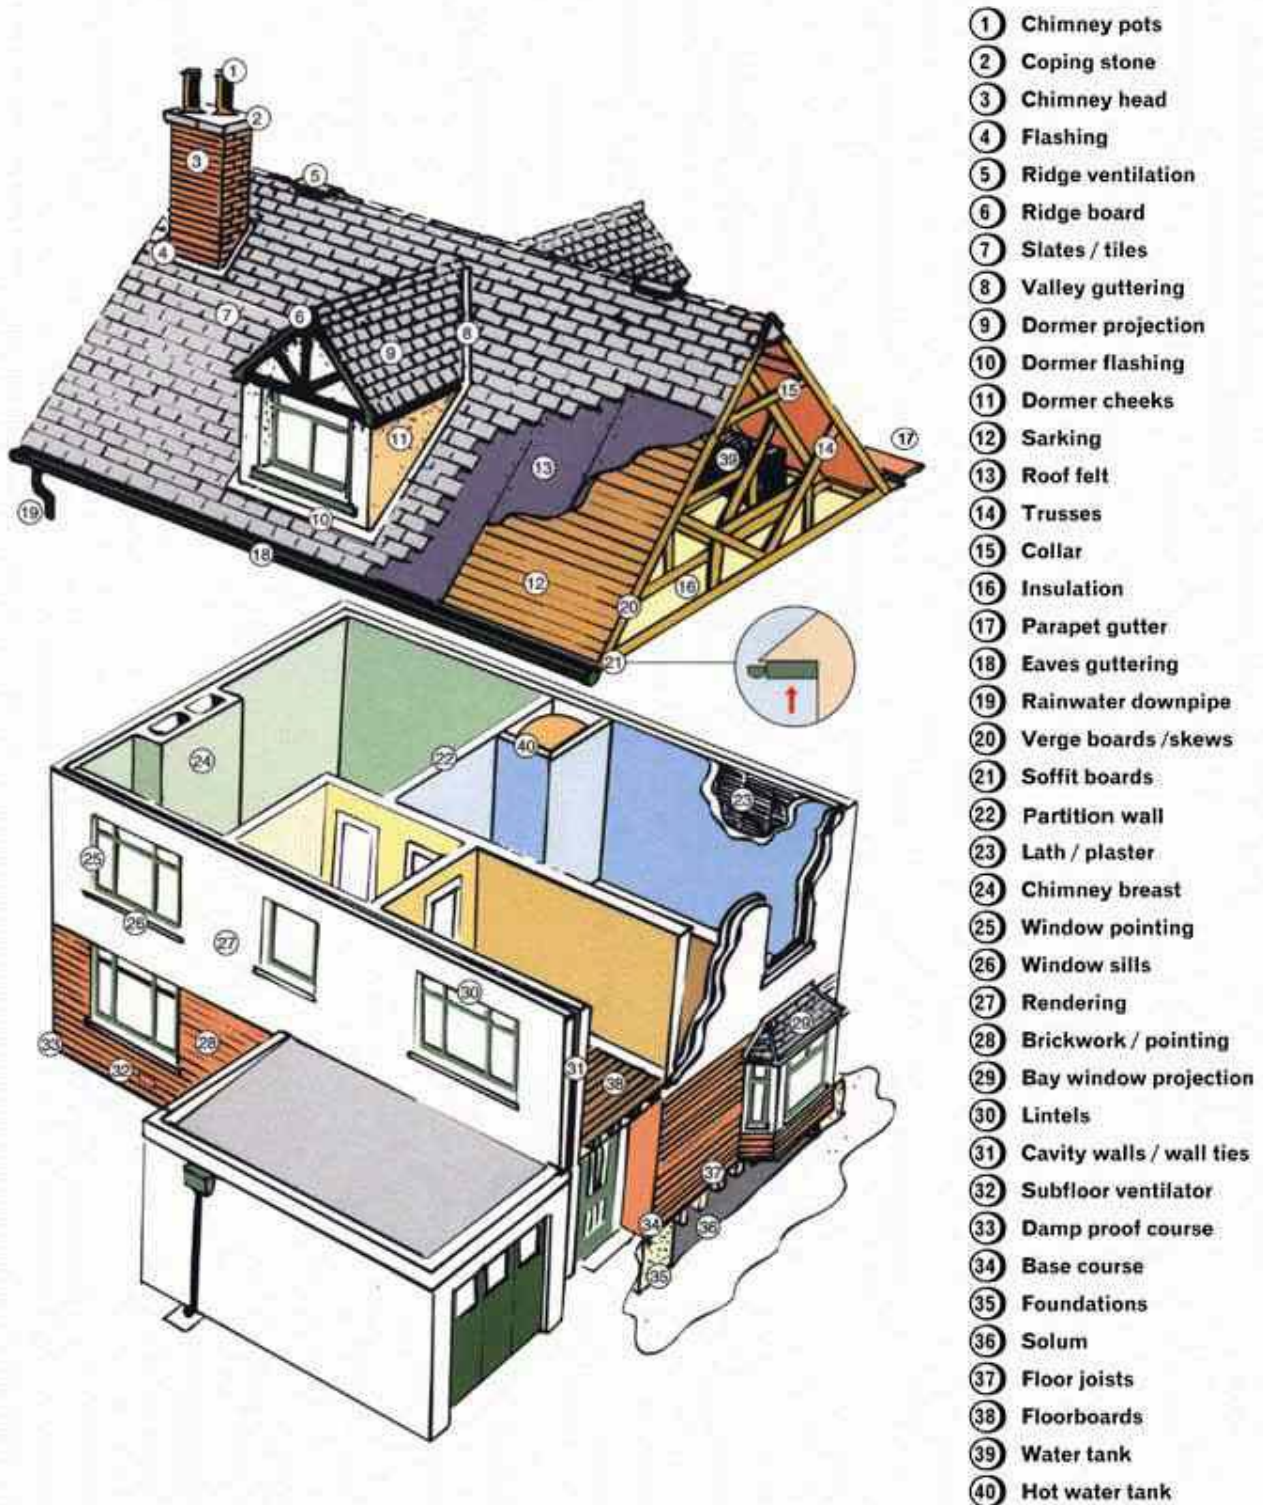
## Sectional Diagram showing elements of a typical house

Reference may be made in this report to some or all of the above component parts of the property. This diagram may assist you in locating and understanding these items.

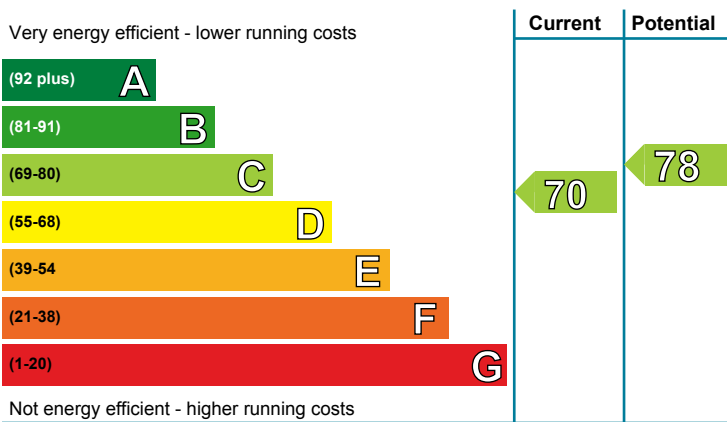
## Energy Efficiency Rating

This graph shows the current efficiency of your home, taking into account both energy efficiency and fuel costs. The higher this rating, the lower your fuel bills are likely to be.

Your current rating is **band C (70)**. The average rating for EPCs in Scotland is **band D (61)**.

The potential rating shows the effect of undertaking all of the improvement measures listed within your recommendations report.

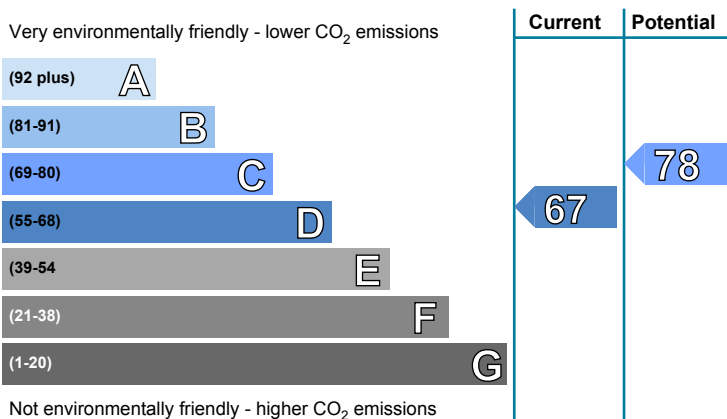
## Environmental Impact (CO<sub>2</sub>) Rating

This graph shows the effect of your home on the environment in terms of carbon dioxide (CO<sub>2</sub>) emissions. The higher the rating, the less impact it has on the environment.
