Home Report

**18 St. Andrews Gardens,
Inverurie, AB51 3XT**

Single Survey

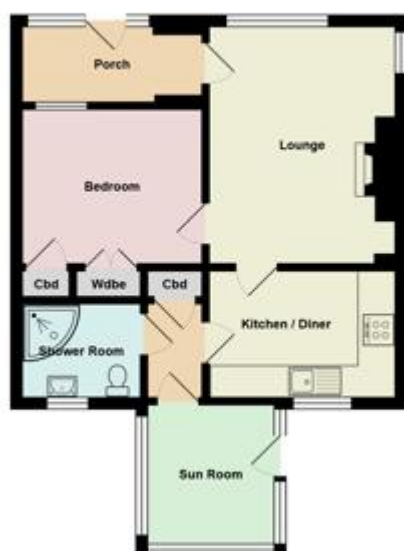
Floorplan

18 St Andrews Gardens
