Home Report

2 Fenerty Place,
Aberdeen, AB24 2PR

Single Survey

Mortgage Valuation Report

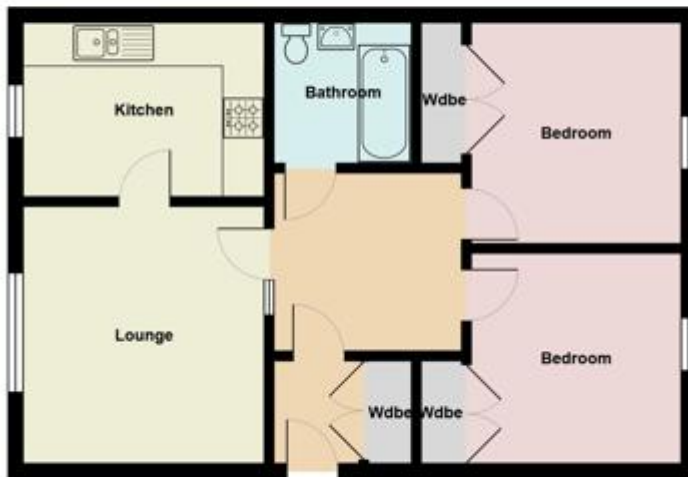
2 Fenerty Place

Floorplan
