Home Report

Single Survey

| Property address | Craigiebuckler Manse Springfield Road Aberdeen AB15 8AA |
| Prepared by | Shepherd Chartered Surveyors |

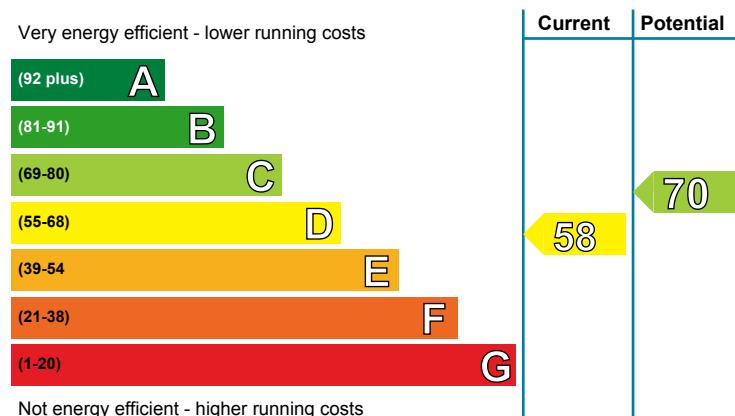
Energy Efficiency Rating

This graph shows the current efficiency of your home, taking into account both energy efficiency and fuel costs. The higher this rating, the lower your fuel bills are likely to be.

Your current rating is **band D (58)**. The average rating for EPCs in Scotland is **band D (61)**.

The potential rating shows the effect of undertaking all of the improvement measures listed within your recommendations report.

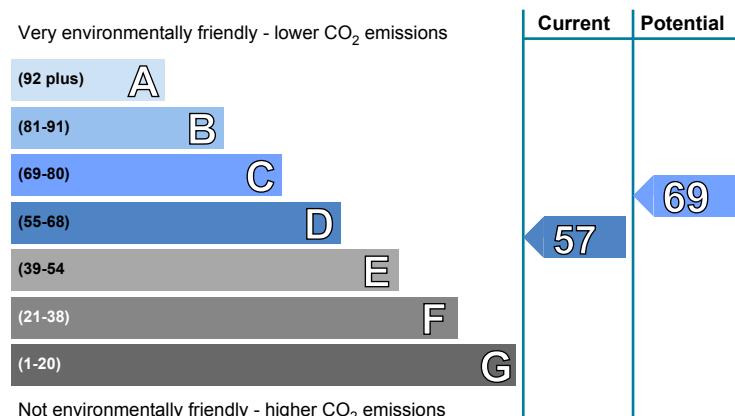
Environmental Impact (CO₂) Rating

This graph shows the effect of your home on the environment in terms of carbon dioxide (CO₂) emissions. The higher the rating, the less impact it has on the environment.
