# Home Report

# Single Survey

<b>Property address</b>	37 Deeside Gardens Aberdeen AB15 7PP
-------------------------	--

<b>Prepared by</b>	Shepherd Chartered Surveyors
--------------------	------------------------------

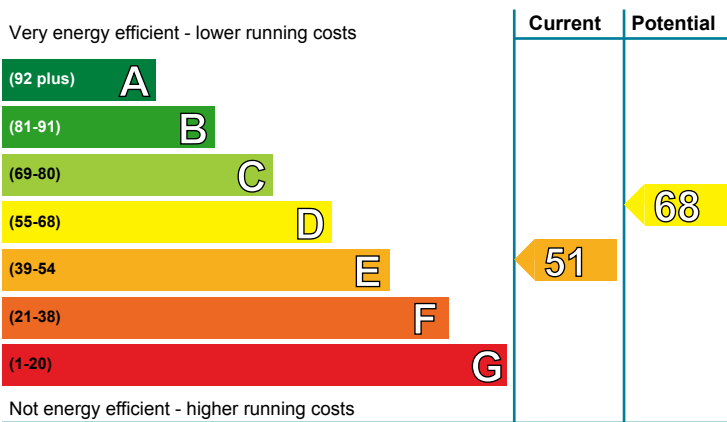
## Energy Efficiency Rating

This graph shows the current efficiency of your home, taking into account both energy efficiency and fuel costs. The higher this rating, the lower your fuel bills are likely to be.

Your current rating is **band E (51)**. The average rating for EPCs in Scotland is **band D (61)**.

The potential rating shows the effect of undertaking all of the improvement measures listed within your recommendations report.

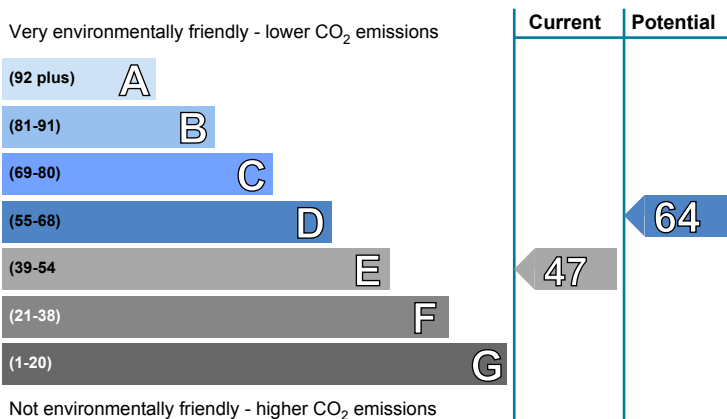
## Environmental Impact (CO<sub>2</sub>) Rating

This graph shows the effect of your home on the environment in terms of carbon dioxide (CO<sub>2</sub>) emissions. The higher the rating, the less impact it has on the environment.
