Home Report

**Mables Gordon Terrace,
Inch, AB52 6WN**

Mables, Gordon Terrace,
Insch, AB52 6WN

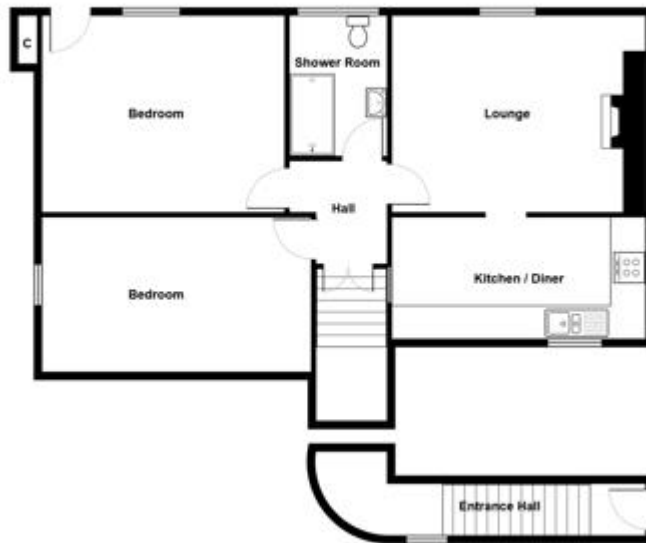
Mables, Gordon Terrace

Floorplan

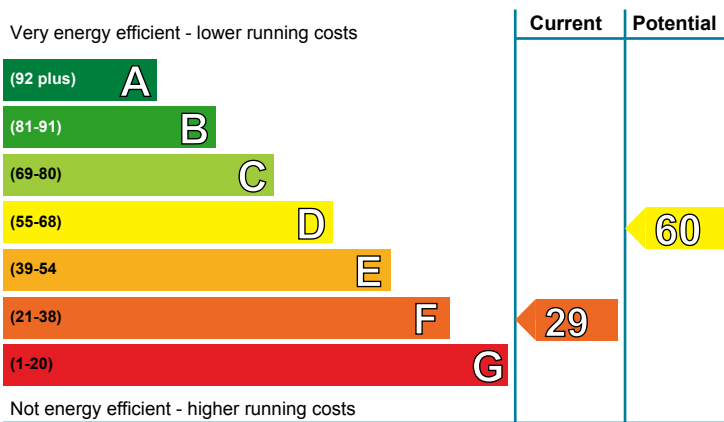
Energy Efficiency Rating

This graph shows the current efficiency of your home, taking into account both energy efficiency and fuel costs. The higher this rating, the lower your fuel bills are likely to be.

Your current rating is **band F (29)**. The average rating for EPCs in Scotland is **band D (61)**.

The potential rating shows the effect of undertaking all of the improvement measures listed within your recommendations report.

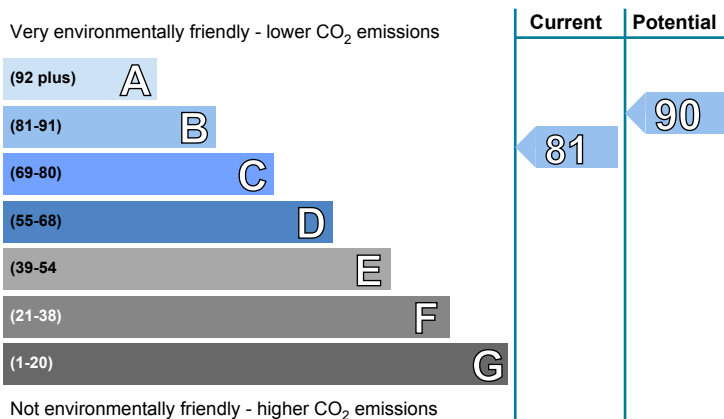
Environmental Impact (CO₂) Rating

This graph shows the effect of your home on the environment in terms of carbon dioxide (CO₂) emissions. The higher the rating, the less impact it has on the environment.
