Home Report

**Eavern Commercial Road,
Oldmeldrum
Inverurie, AB51 0DT**

Single Survey

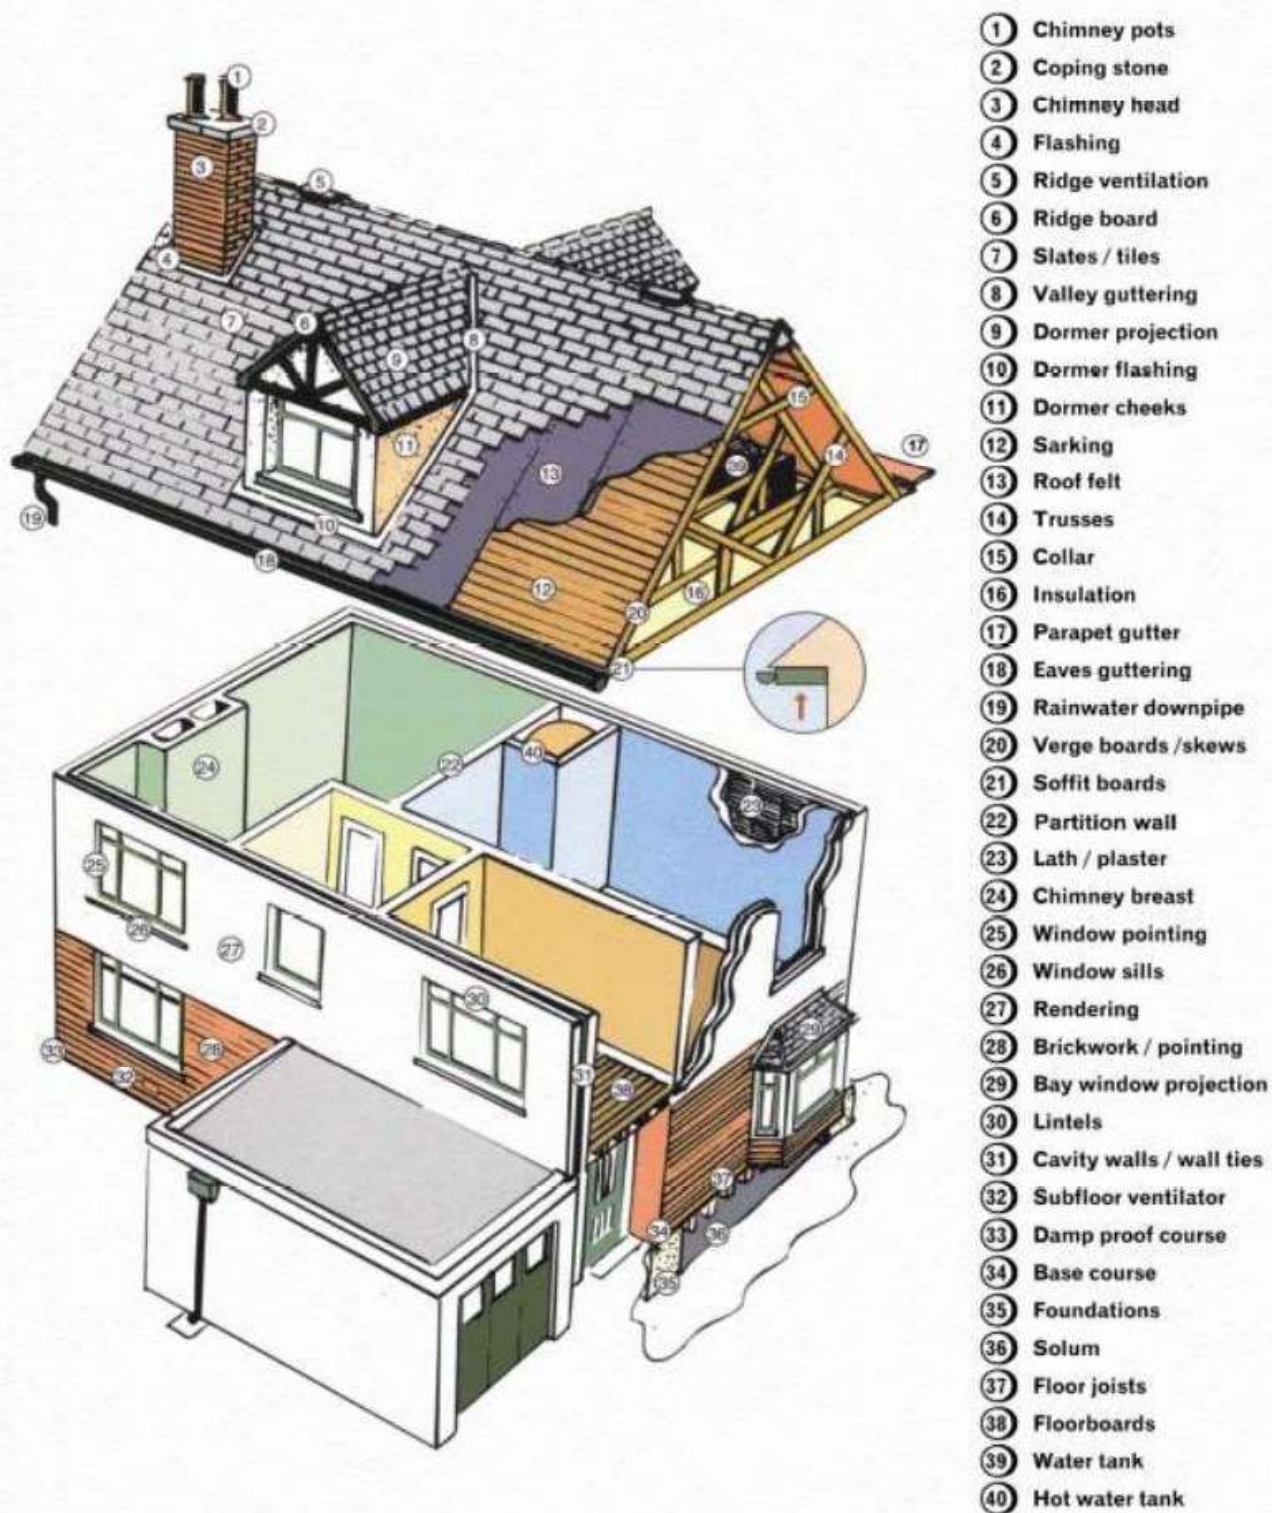
Sectional Diagram showing elements of a typical house

Reference may be made in this report to some or all of the above component parts of the property. This diagram may assist you in locating and understanding these items.

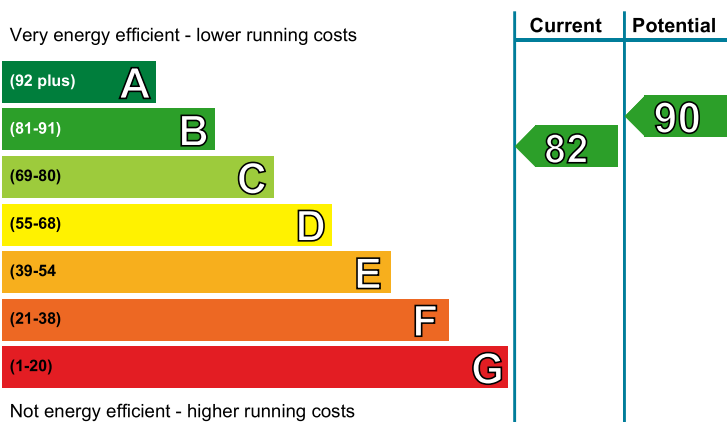
Energy Efficiency Rating

This graph shows the current efficiency of your home, taking into account both energy efficiency and fuel costs. The higher this rating, the lower your fuel bills are likely to be.

Your current rating is **band B (82)**. The average rating for EPCs in Scotland is **band D (61)**.

The potential rating shows the effect of undertaking all of the improvement measures listed within your recommendations report.

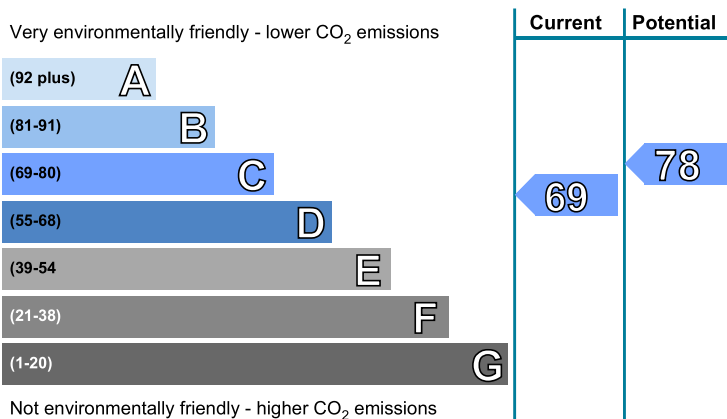
Environmental Impact (CO₂) Rating

This graph shows the effect of your home on the environment in terms of carbon dioxide (CO₂) emissions. The higher the rating, the less impact it has on the environment.
