Home Report

3 Barnyards Of Drumnaheath Kintore

Inverurie, AB51 0YE

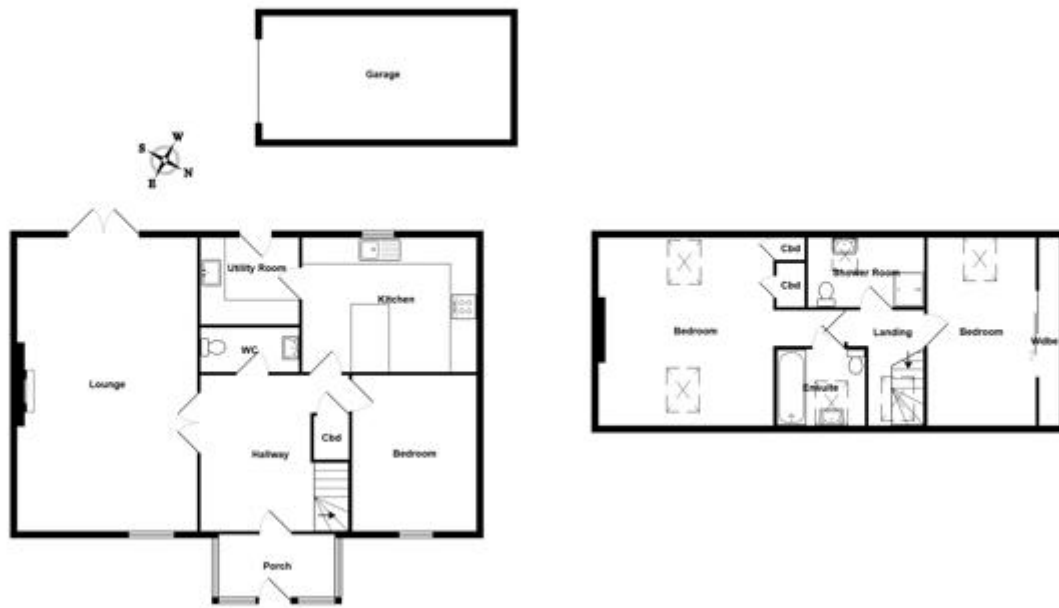
Floorplan

3 Barnyards of Drumsnaheath

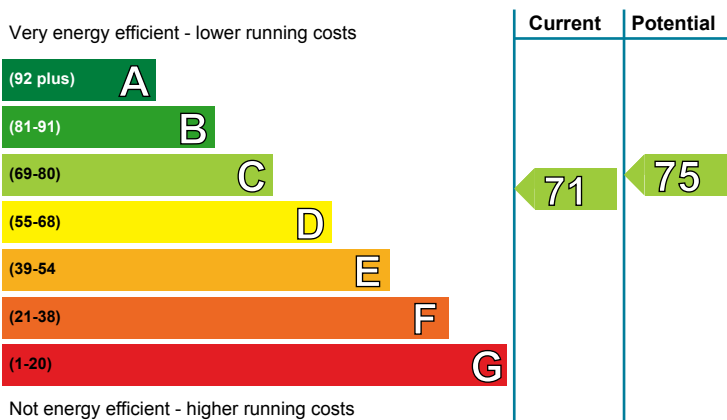
Energy Efficiency Rating

This graph shows the current efficiency of your home, taking into account both energy efficiency and fuel costs. The higher this rating, the lower your fuel bills are likely to be.

Your current rating is **band C (71)**. The average rating for EPCs in Scotland is **band D (61)**.

The potential rating shows the effect of undertaking all of the improvement measures listed within your recommendations report.

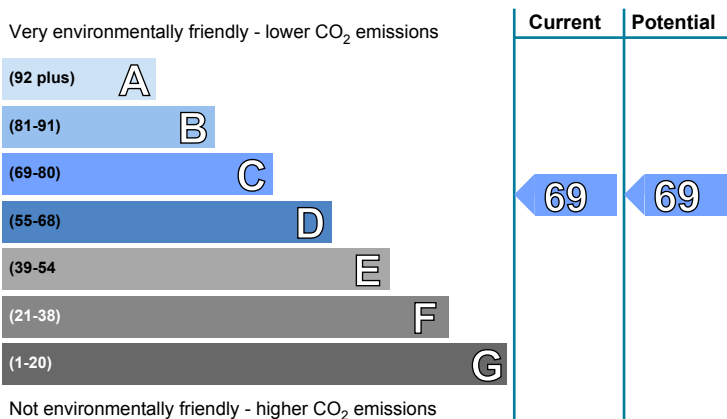
Environmental Impact (CO₂) Rating

This graph shows the effect of your home on the environment in terms of carbon dioxide (CO₂) emissions. The higher the rating, the less impact it has on the environment.
