Home Report

Single Survey

Property address	The Mill Steading 3 Culdrain Steading Gartly Huntly AB54 4PY
Customer	Mr Peter Hare
Customer address	The Mill Steading 3 Culdrain Steading Gartly Huntly AB54 4PY
Prepared by	Shepherd Chartered Surveyors
Date of inspection	26/02/2026

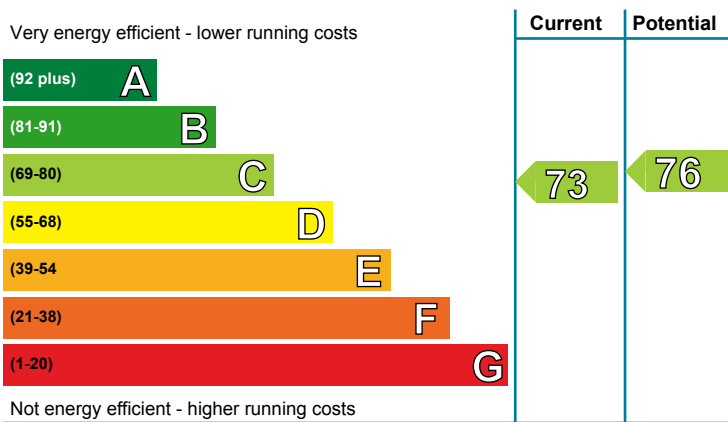
Energy Efficiency Rating

This graph shows the current efficiency of your home, taking into account both energy efficiency and fuel costs. The higher this rating, the lower your fuel bills are likely to be.

Your current rating is **band C (73)**. The average rating for EPCs in Scotland is **band D (61)**.

The potential rating shows the effect of undertaking all of the improvement measures listed within your recommendations report.

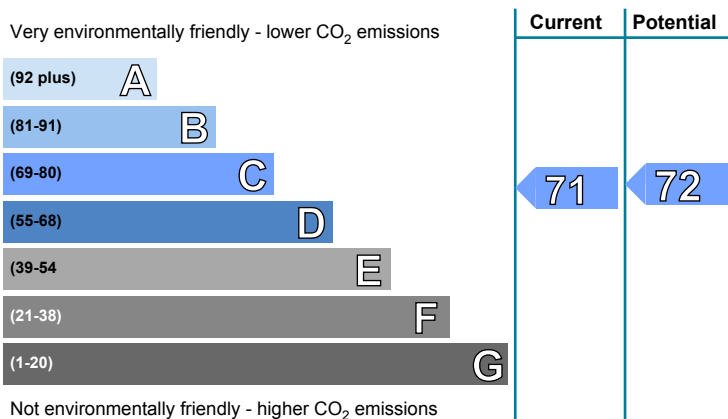
Environmental Impact (CO₂) Rating

This graph shows the effect of your home on the environment in terms of carbon dioxide (CO₂) emissions. The higher the rating, the less impact it has on the environment.
