Knock House,
10 Knock Street,
Whitehills,
Banff,
AB45 2NW

Home Report

Single Survey

Property Address	Knock House, 10 Knock Street, Whitehills, Banff, AB45 2NW
Reference	1426462
Customer Name	Executors of the late Liliac C Watson
Date of Inspection	12th February 2026
Surveyor's name, qualifications and office	Darroch Robertson BSc (Hons) MRICS DM Hall LLP Chartered Surveyors 64 Market Place Inverurie AB51 3XN Tel: 01467 624393 email: inverurieresidential@dmhall.co.uk
Prepared By	DM Hall LLP

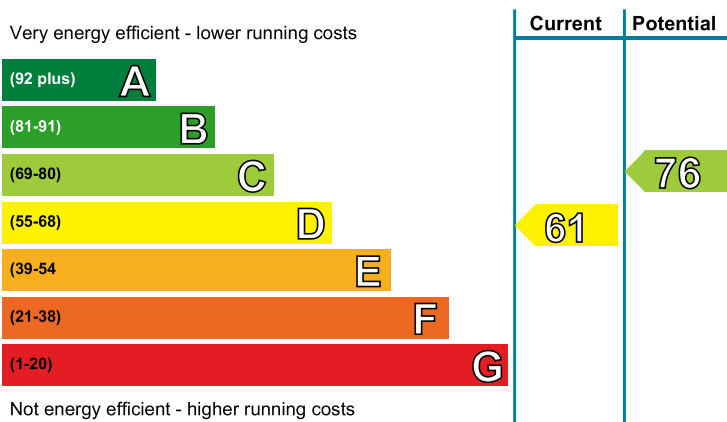
Energy Efficiency Rating

This graph shows the current efficiency of your home, taking into account both energy efficiency and fuel costs. The higher this rating, the lower your fuel bills are likely to be.

Your current rating is **band D (61)**. The average rating for EPCs in Scotland is **band D (61)**.

The potential rating shows the effect of undertaking all of the improvement measures listed within your recommendations report.

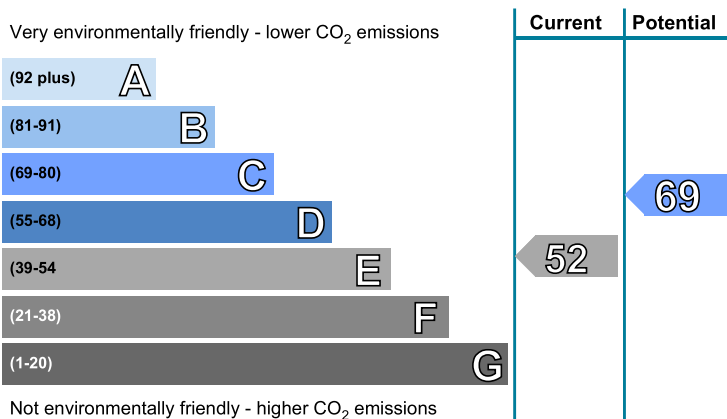
Environmental Impact (CO₂) Rating

This graph shows the effect of your home on the environment in terms of carbon dioxide (CO₂) emissions. The higher the rating, the less impact it has on the environment.
