Home Report

Scottish Single Survey

Single Survey

Property address	34 Papermill Avenue Aberdeen AB24 2PB
-------------------------	---

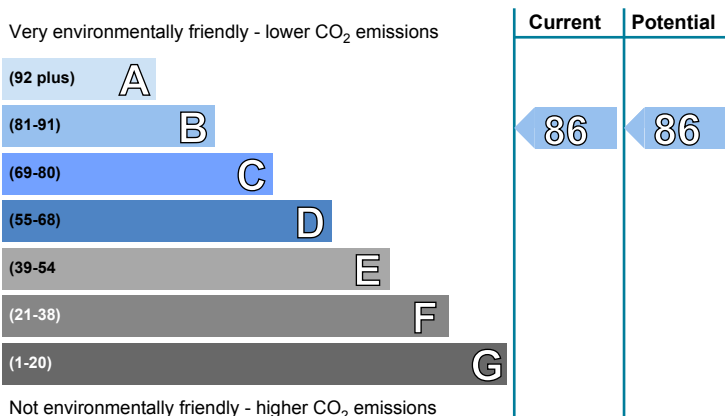
Environmental Impact (CO₂) Rating

This graph shows the effect of your home on the environment in terms of carbon dioxide (CO₂) emissions. The higher the rating, the less impact it has on the environment.
