Home Report

Drewanlea Oyne,
Insch, AB52 6QR

Single Survey

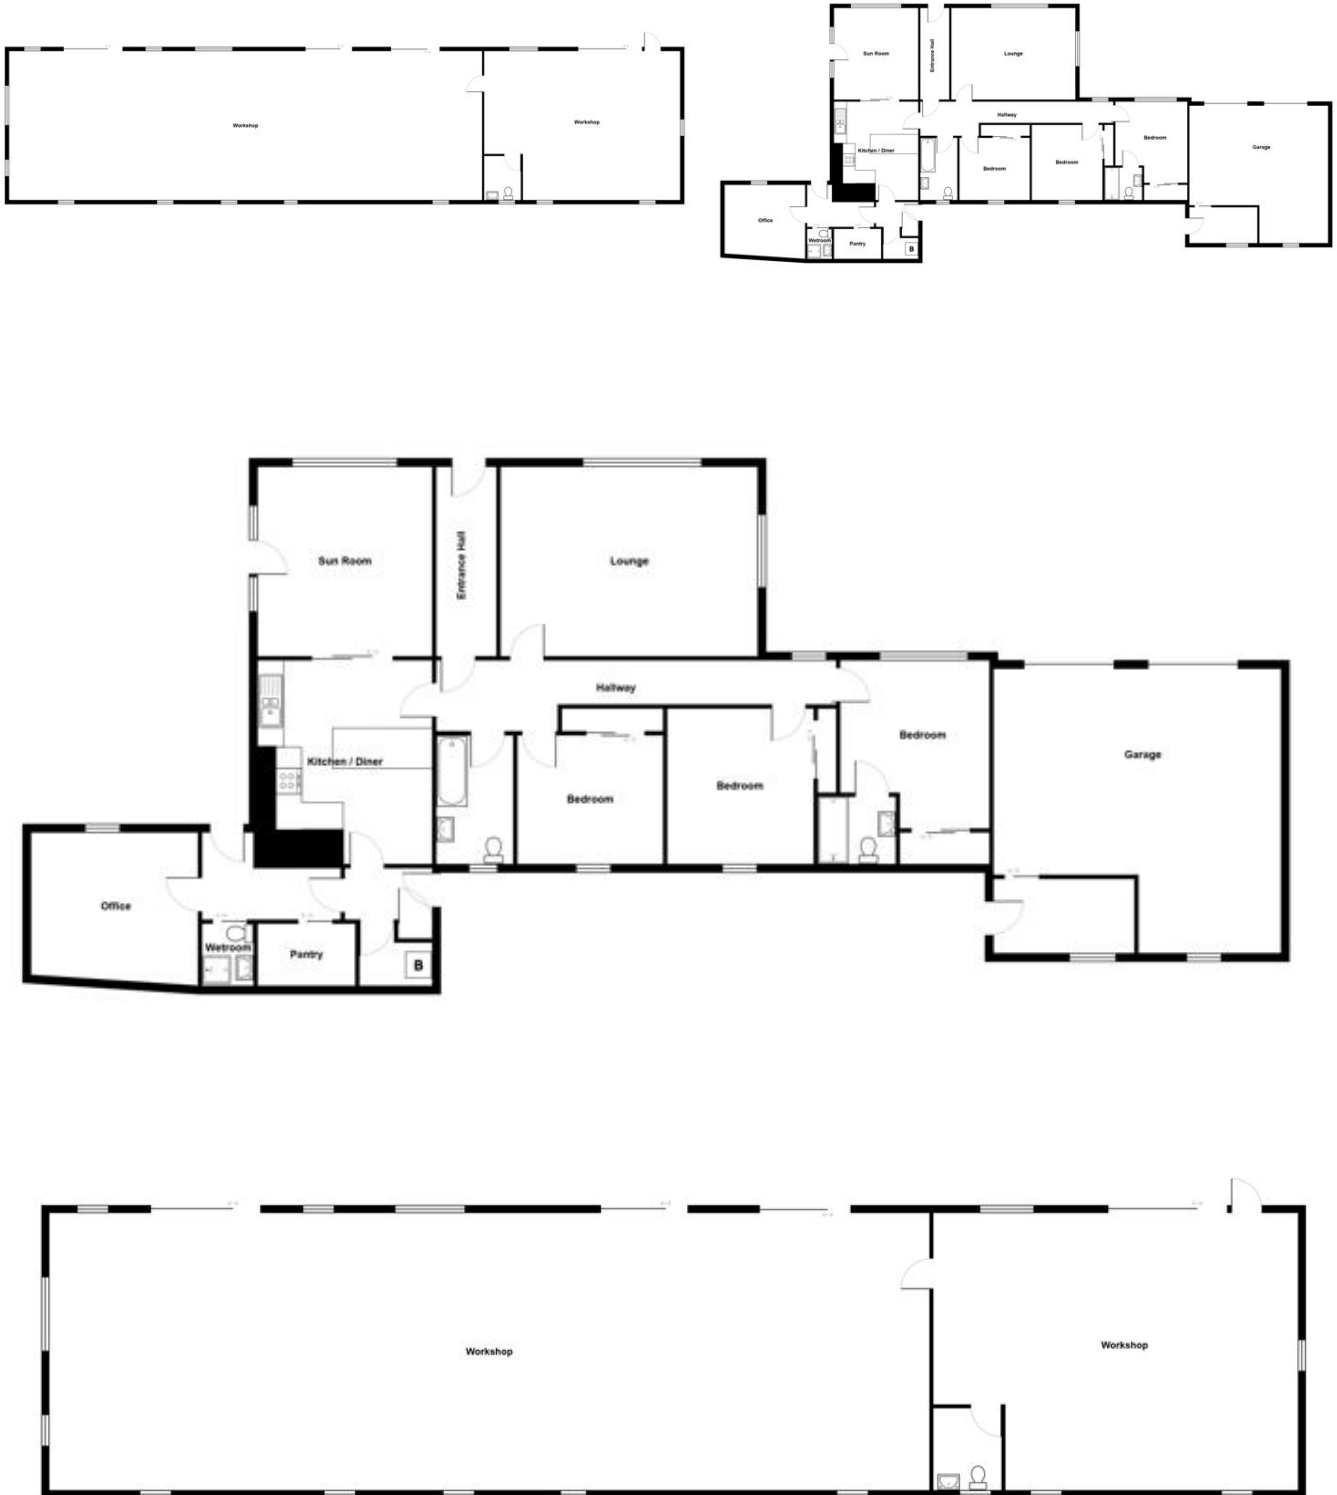
Drawings, Oyne

Floorplan

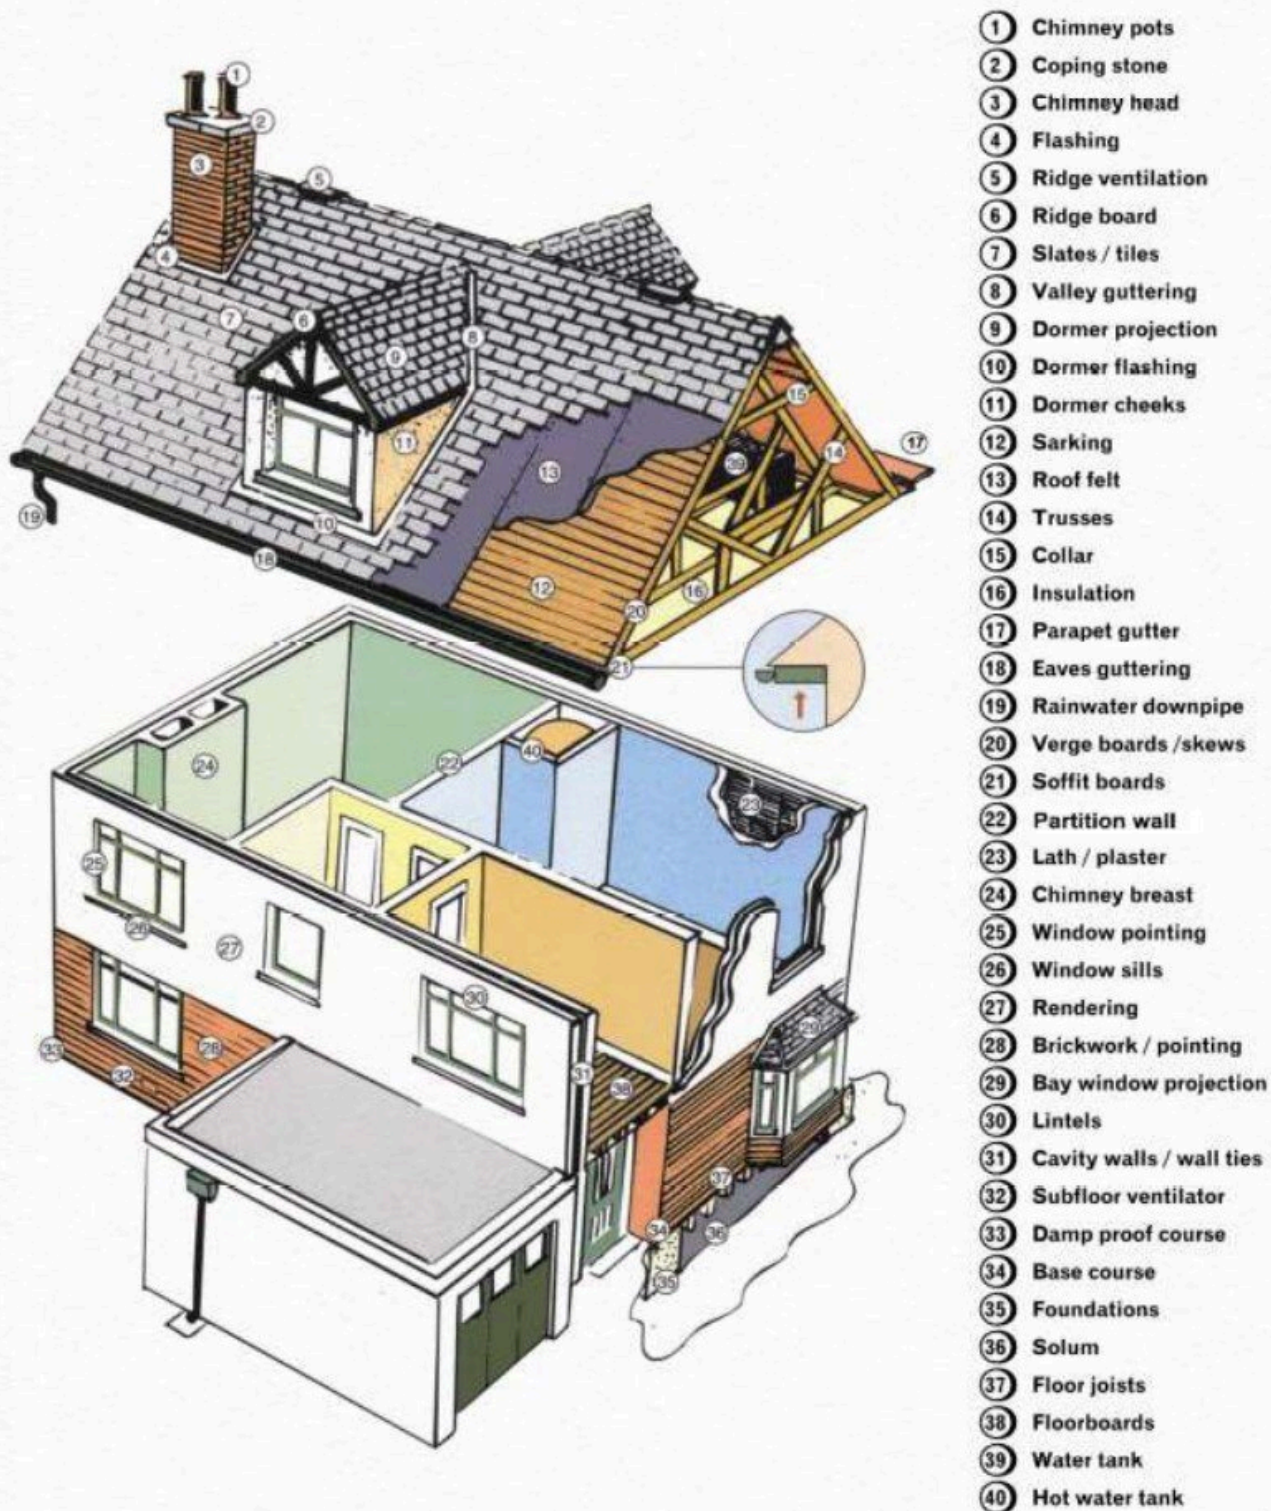
Sectional Diagram showing elements of a typical house

Reference may be made in this report to some or all of the above component parts of the property. This diagram may assist you in locating and understanding these items.
