Home Report

27 Beech Court, Kemnay
Inverurie, AB51 5PY

Set within a quiet residential cul-de-sac, this **2 bedroom self-contained upper floor flat** is in easy walking distance of the local shops and amenities.

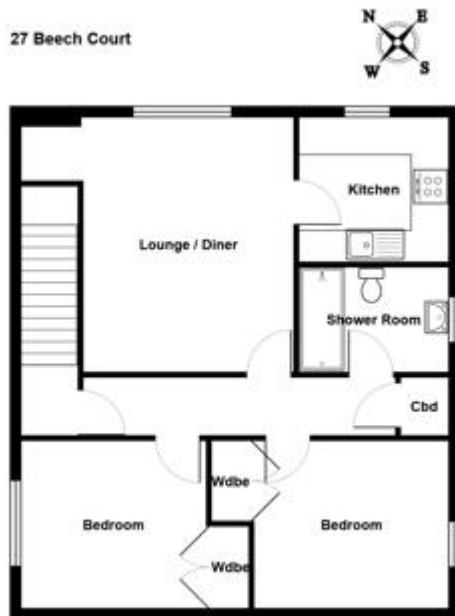
Floorplan

Accommodation comprises

Entrance: Door opens into the entrance staircase which is carpeted with a low level cupboard housing the consumer unit and meter. Ceiling light; smoke alarm and telephone point. Door at the top landing into the hallway.

Hall: The hallway gives access to all accommodation with a large storage cupboard at the end with fitted shelving. Downlights; smoke alarm and wood effect flooring.

Living room: 4.34m x 3.53m (14'3" x 11'7") approx. A good sized bright room with space for a range of freestanding lounge furniture along with a dining table if desired. Inset space with fitted glass display shelving. Window to the front fills the room with natural light. Downlights; television and telephone points; smoke alarm and wood effect flooring. Door into the kitchen.

Kitchen: 2.56m x 2.51m (8'5" x 8'3") approx. Fitted with a range of base and wall units, coordinating worktops, upstands and splashbacks. Stainless steel single bowl sink with drainer and mixer tap. Integrated fridge freezer, oven and gas hob with chimney style extractor hood above. Space with washing machine. Central heating boiler housed in wall unit. Window with roller blind. Ceiling light; smoke and carbon monoxide alarm and wood effect flooring.
