Home Report

Single Survey

Property address	62F Elmbank Terrace Aberdeen AB24 3NL
Customer	James Allan & Hazle Ibbetson
Customer address	62F Elmbank Terrace Aberdeen AB24 3NL
Prepared by	Shepherd Chartered Surveyors
Date of inspection	16/04/2026

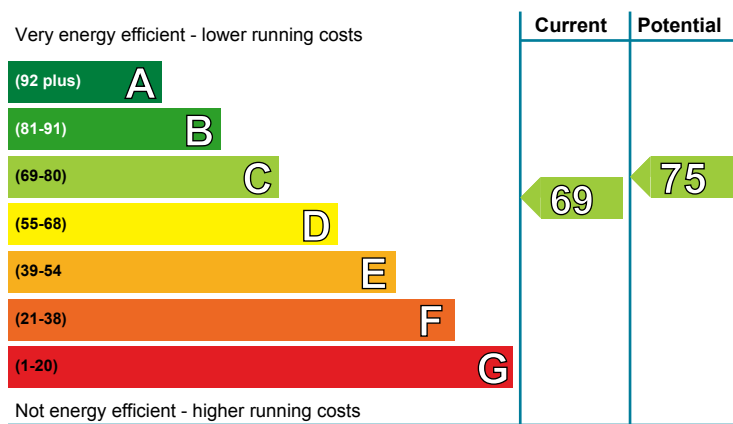
Energy Efficiency Rating

This graph shows the current efficiency of your home, taking into account both energy efficiency and fuel costs. The higher this rating, the lower your fuel bills are likely to be.

Your current rating is **band C (69)**. The average rating for EPCs in Scotland is **band D (61)**.

The potential rating shows the effect of undertaking all of the improvement measures listed within your recommendations report.

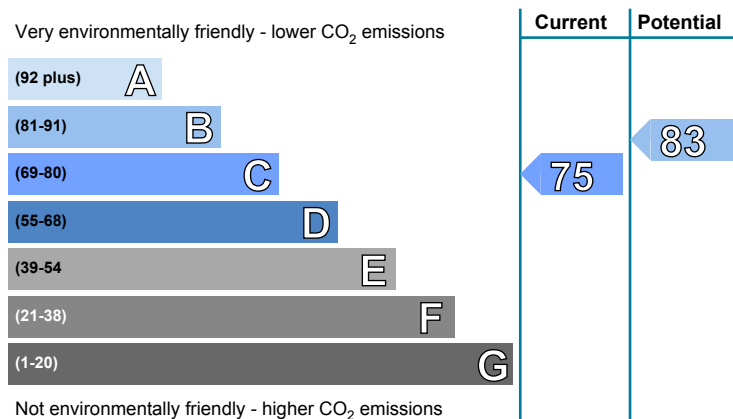
Environmental Impact (CO₂) Rating

This graph shows the effect of your home on the environment in terms of carbon dioxide (CO₂) emissions. The higher the rating, the less impact it has on the environment.
