# Home Report

**28 Isla Place, Mastrick**  
**Aberdeen, AB16 6TE**

# Single Survey

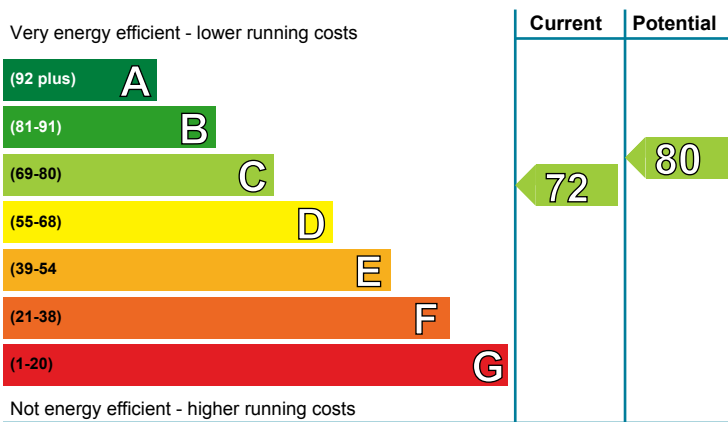
## Energy Efficiency Rating

This graph shows the current efficiency of your home, taking into account both energy efficiency and fuel costs. The higher this rating, the lower your fuel bills are likely to be.

Your current rating is **band C (72)**. The average rating for EPCs in Scotland is **band D (61)**.

The potential rating shows the effect of undertaking all of the improvement measures listed within your recommendations report.

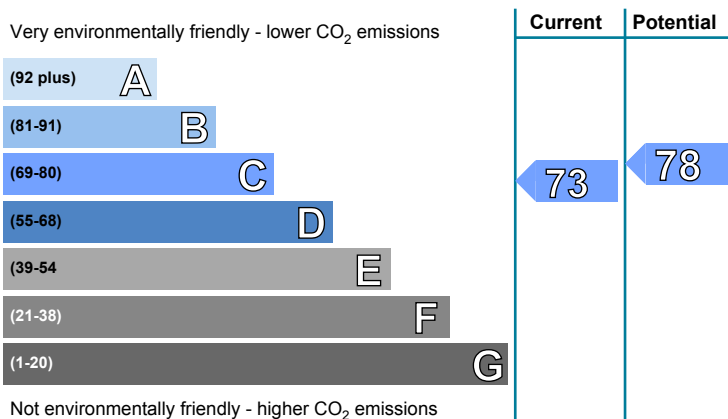
## Environmental Impact (CO<sub>2</sub>) Rating

This graph shows the effect of your home on the environment in terms of carbon dioxide (CO<sub>2</sub>) emissions. The higher the rating, the less impact it has on the environment.
