# Home Report

**Springbank Barreldykes Way, Old  
Rayne**  
Insch, AB52 6SA

# Single Survey

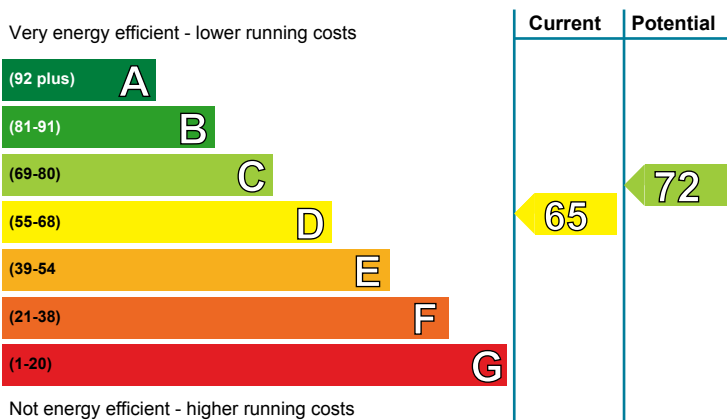
## Energy Efficiency Rating

This graph shows the current efficiency of your home, taking into account both energy efficiency and fuel costs. The higher this rating, the lower your fuel bills are likely to be.

Your current rating is **band D (65)**. The average rating for EPCs in Scotland is **band D (61)**.

The potential rating shows the effect of undertaking all of the improvement measures listed within your recommendations report.

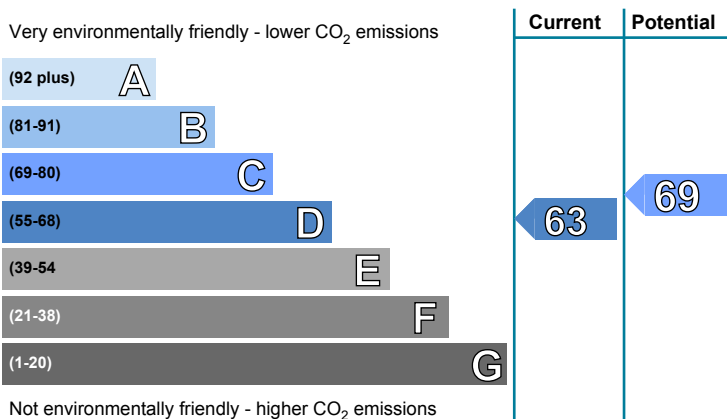
## Environmental Impact (CO<sub>2</sub>) Rating

This graph shows the effect of your home on the environment in terms of carbon dioxide (CO<sub>2</sub>) emissions. The higher the rating, the less impact it has on the environment.
