Home Report

Scottish Single Survey

Property address	57 Gairn Mews Gairn Terrace Aberdeen AB10 6FN
Customer	Glenn Buchan
Customer address	57 Gairn Mews Gairn Terrace Aberdeen AB10 6FN
Prepared by	Shepherd Chartered Surveyors
Date of inspection	12/05/2026

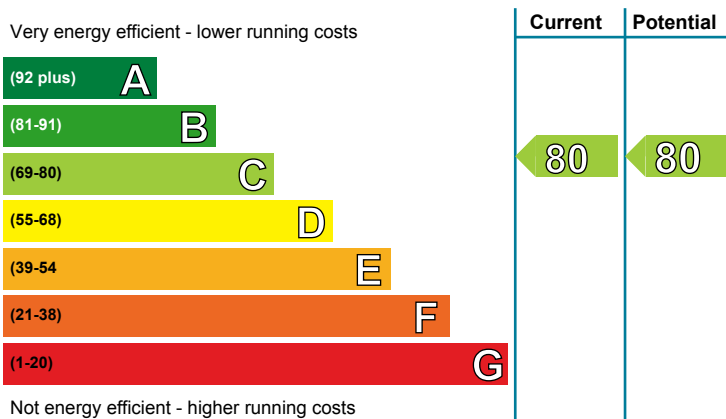
Energy Efficiency Rating

This graph shows the current efficiency of your home, taking into account both energy efficiency and fuel costs. The higher this rating, the lower your fuel bills are likely to be.

Your current rating is **band C (80)**. The average rating for EPCs in Scotland is **band D (61)**.

The potential rating shows the effect of undertaking all of the improvement measures listed within your recommendations report.

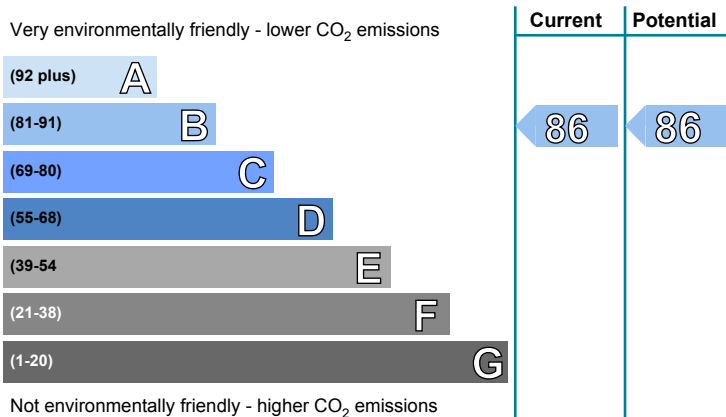
Environmental Impact (CO₂) Rating

This graph shows the effect of your home on the environment in terms of carbon dioxide (CO₂) emissions. The higher the rating, the less impact it has on the environment.
