# Home Report

**109 Cordiner Avenue,**  
**Aberdeen, AB24 4SA**

# Single Survey

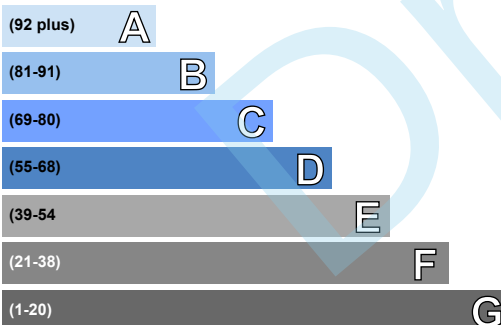
Very environmentally friendly - lower CO<sub>2</sub> emissions

Not environmentally friendly - higher CO<sub>2</sub> emissions
