Home Report

36 St. Thomas, Monymusk
Inverurie, AB51 7HQ

Price Over
£270,000

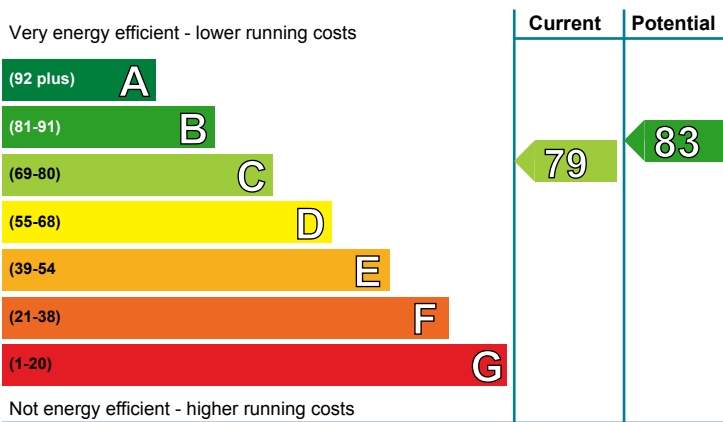
Energy Efficiency Rating

This graph shows the current efficiency of your home, taking into account both energy efficiency and fuel costs. The higher this rating, the lower your fuel bills are likely to be.

Your current rating is **band C (79)**. The average rating for EPCs in Scotland is **band D (61)**.

The potential rating shows the effect of undertaking all of the improvement measures listed within your recommendations report.

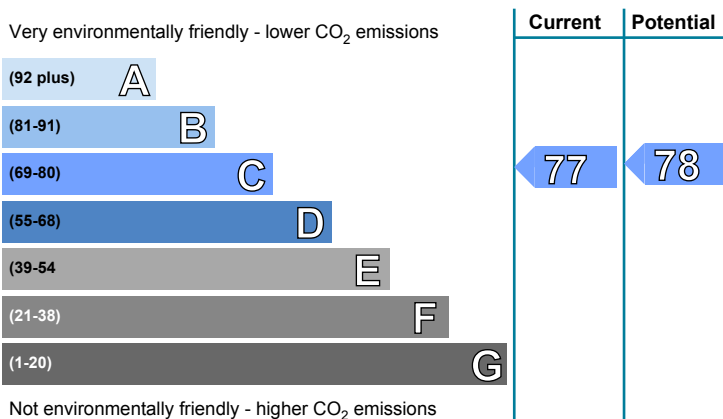
Environmental Impact (CO₂) Rating

This graph shows the effect of your home on the environment in terms of carbon dioxide (CO₂) emissions. The higher the rating, the less impact it has on the environment.
