Home Report

5 The Glebe,
Kemnay, Inverurie, AB51 5NF

Single Survey

Mortgage Valuation Report

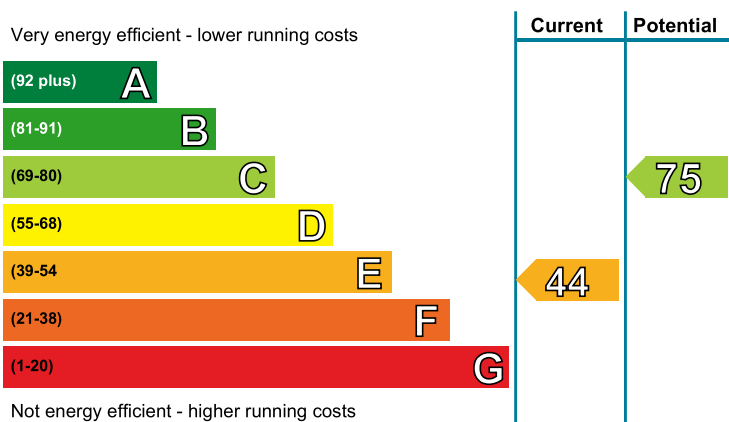
Energy Efficiency Rating

This graph shows the current efficiency of your home, taking into account both energy efficiency and fuel costs. The higher this rating, the lower your fuel bills are likely to be.

Your current rating is **band E (44)**. The average rating for EPCs in Scotland is **band D (61)**.

The potential rating shows the effect of undertaking all of the improvement measures listed within your recommendations report.

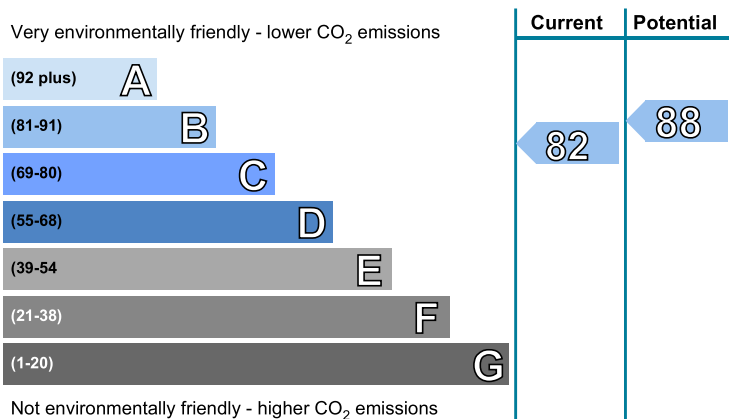
Environmental Impact (CO₂) Rating

This graph shows the effect of your home on the environment in terms of carbon dioxide (CO₂) emissions. The higher the rating, the less impact it has on the environment.
